# New Glass - Old Panels

by Dennis Wolter

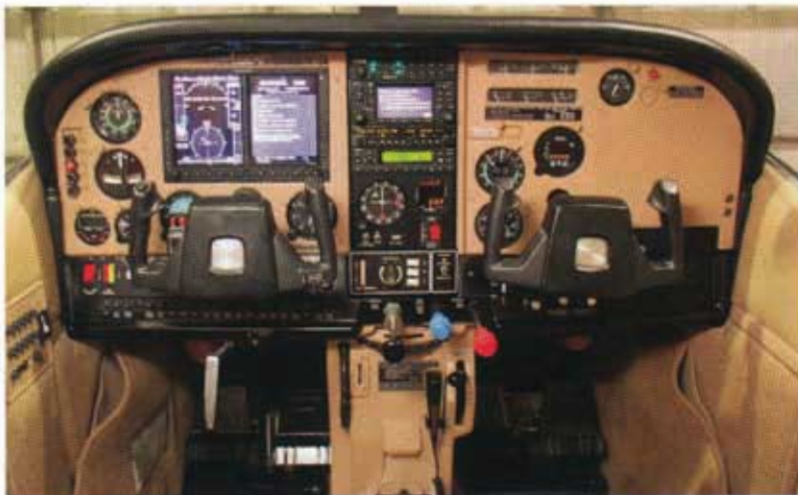
*Cosmetically renovated 210 panel, modified to accommodate a Garmin 500 system and more.*

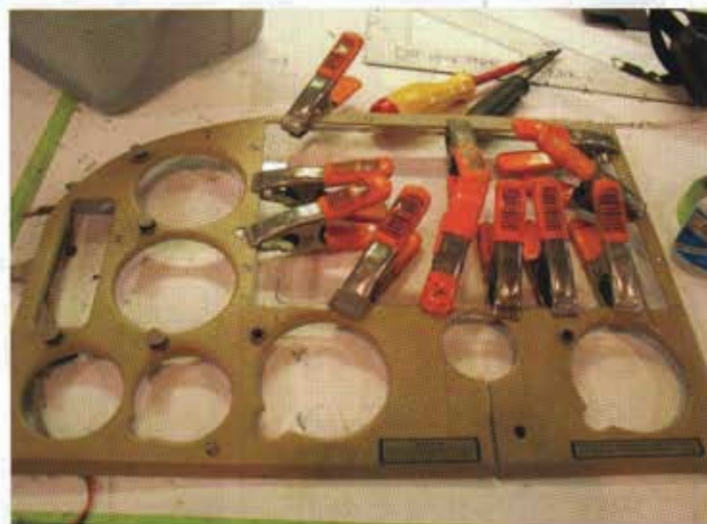
*1/4" acrylic doubler being bonded to the original plastic overlay.*

Each installation is totally custom, with no two panels in any model being the same. Vacuum forming an entirely new overlay would be a costly process involving complex tooling, so we've developed a method of locating a large rectangular cut-out in the plastic overlay and bonding a 1/4" acrylic lip to the back side of the overlay. We then use 80-grit sandpaper bonded to a paint stick to hand sculpt a finished radius to the new cut-out, resulting in a hole that looks like it was molded into the overlay at the factory. Apply a little filler and primer and you are ready to paint.

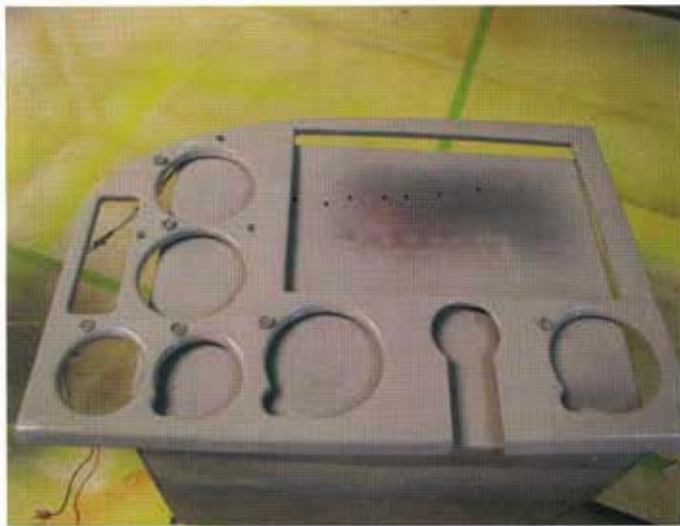
*The panel overlay is sanded, filled, primed and ready for paint.*

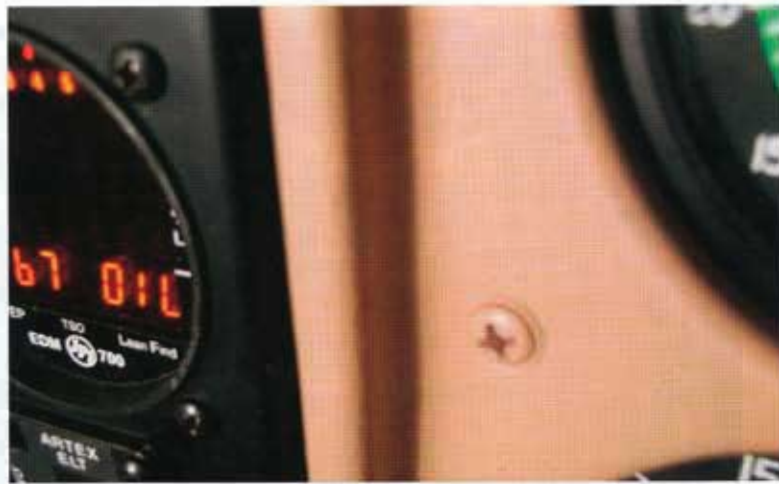
*Painted finish screw and washer. Looks good, holds firmly and is easy to install and remove – wow!*

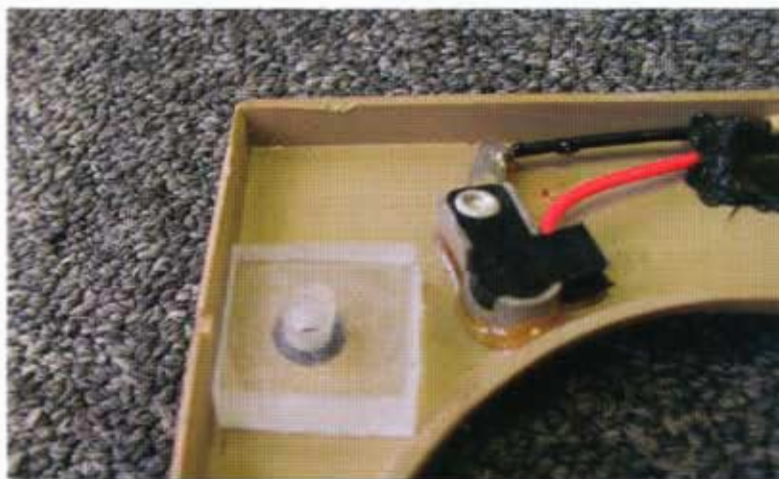
*1/4" acrylic mounting screw doubler bonded to the back side of the panel overlay.*

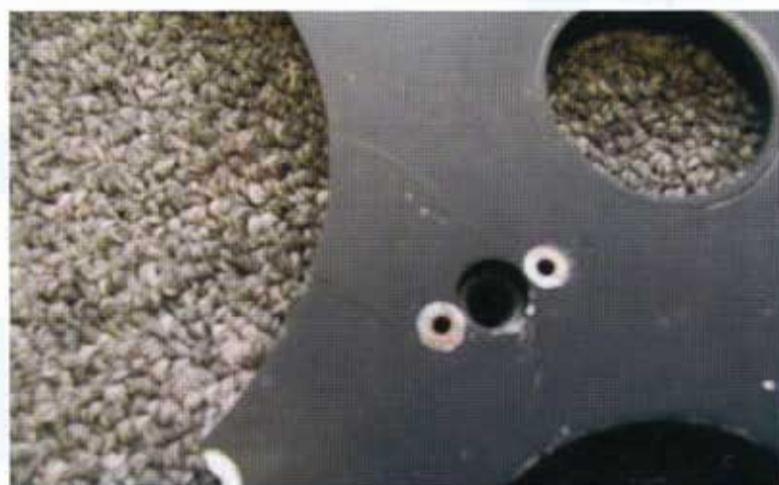
*An 8-32 nutplate installed in an oversized hole.*

tic pin that mated to a rubber grommet and hole in the metal instrument mounting panel. This hole for the grommet is too large for an 8-32 rivnut, making it necessary to install an 8-32 nut plate on the back side of the instrument mounting panel centered on the original oversized hole. This takes a little more time, but is definitely worth the effort.

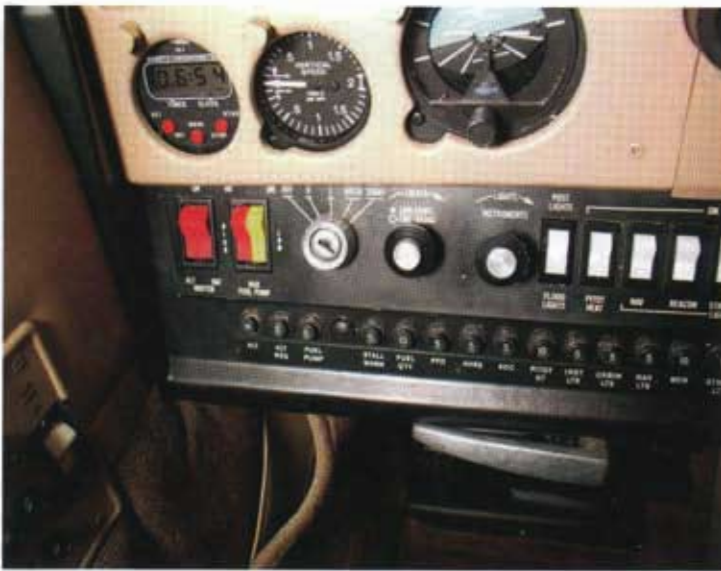
*Repaired, re-painted and placarded sub-panel with removable circuit breaker placard strip.*

Here is a big time saver that will allow you to avoid the tedious process of placarding all of those circuit breakers while in an awkward position in the airplane. Fabricate a .040" aluminum strip that is mounted with three or four short 4-40 countersunk machine screws tapped into the aluminum sub-panel structure. Paint and placard this strip out of the airplane. Any future changes to the placarding is a snap; just remove the strip and make the change.

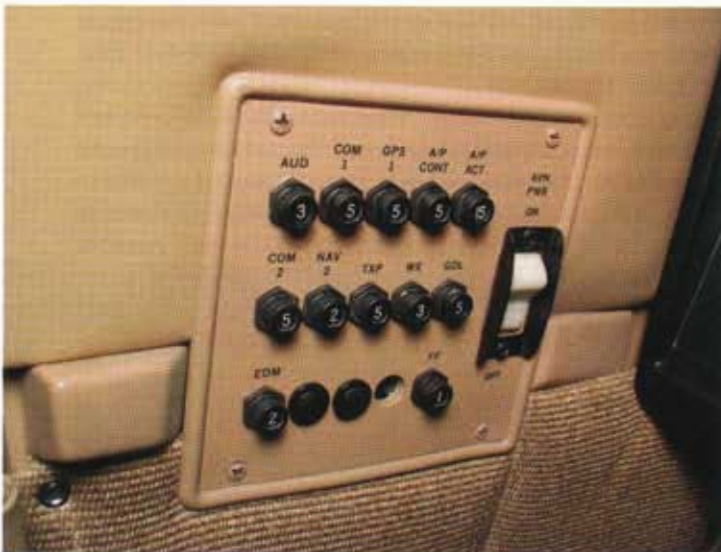
*Renovated side panel circuit breaker panel.*

The pedestal and side panel circuit breaker panel are removed, repaired, painted and placarded using the same methods as used on the instrument panel overlays and sub-panel components housing controls and circuit breakers.

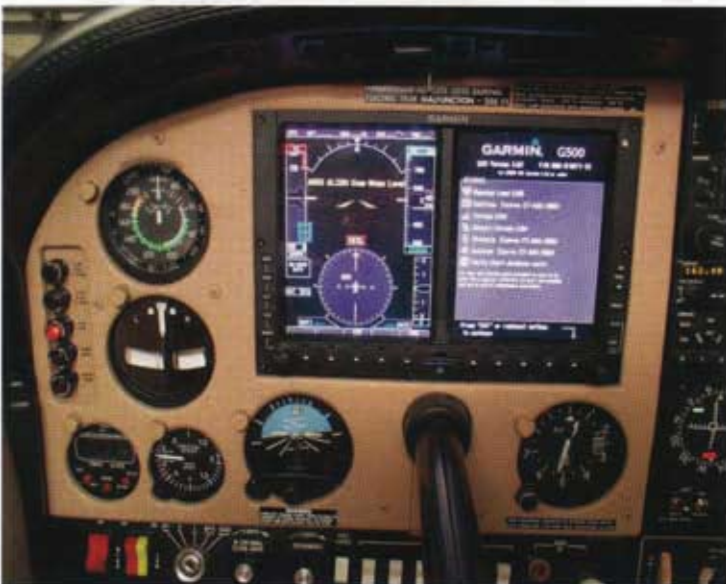
*Close-up of the renovated panel with the Garmin 500 installed.*
