Renovating the ABS/ASF A36

Part Six: Glareshield

By Dennis and Cynthia Wolter, Air Mod

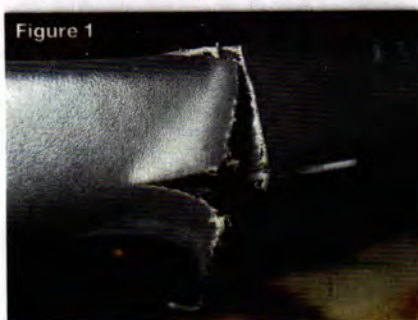
Figure 1

year old Bonanzas. Cracks in the aft formed lip (**figure 1**) are definitely previews of coming attractions. Once the cover material and the light rack are removed, the true extent of the damage to the plastic substrate is revealed (**figure 2**). The first step in the repair process is to re-form and repair the damaged lip with Polyfix adhesive and model makers' fiberglass as described in the window frame repair article in the December issue of this magazine. The next step is to reinforce the repaired lip with a .040" aluminum riveted-in-place contoured doubler secured with 1/8" hardware store pop rivets (**figure 3**).

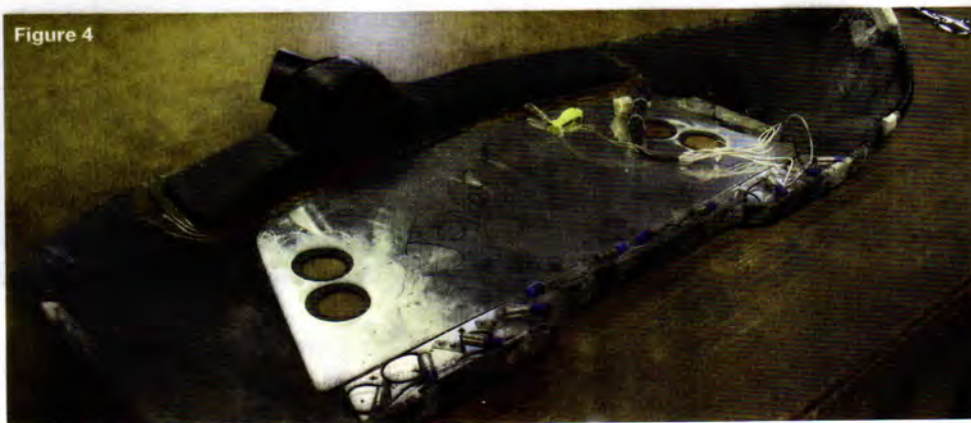
Figure 4

Cracks can also be found in the main body of the glareshield. The fix for this is

to cut a 0.020" aluminum doubler, which is then bonded to the back surface of the damaged areas with contact cement and secured to the edges of the doubler with $\frac{1}{8}$ " hardware store pop rivets (**figure 4**).

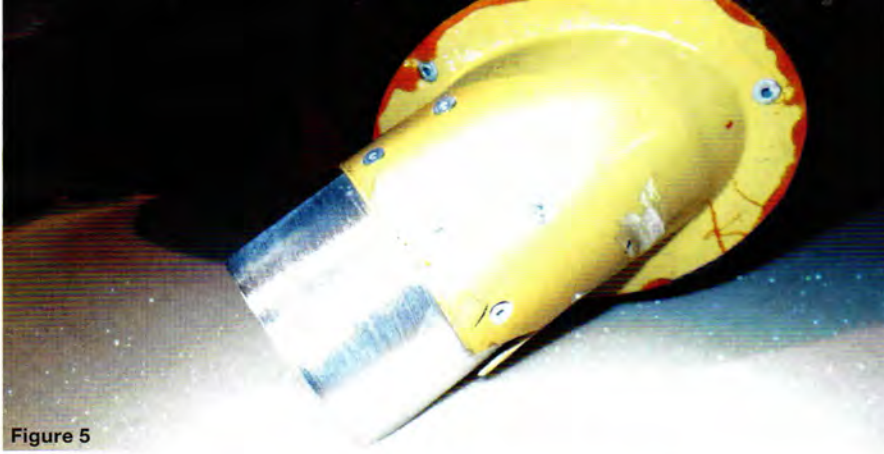
Figure 5

Another common problem is heat deformation of the defroster hose flange. The fix for this is to rivet a three-inch length of aluminum tubing that is pushed into the deformed plastic flange and secured with those wonderfully useful, hardware store pop rivets (**figure 5**). This works *great!*

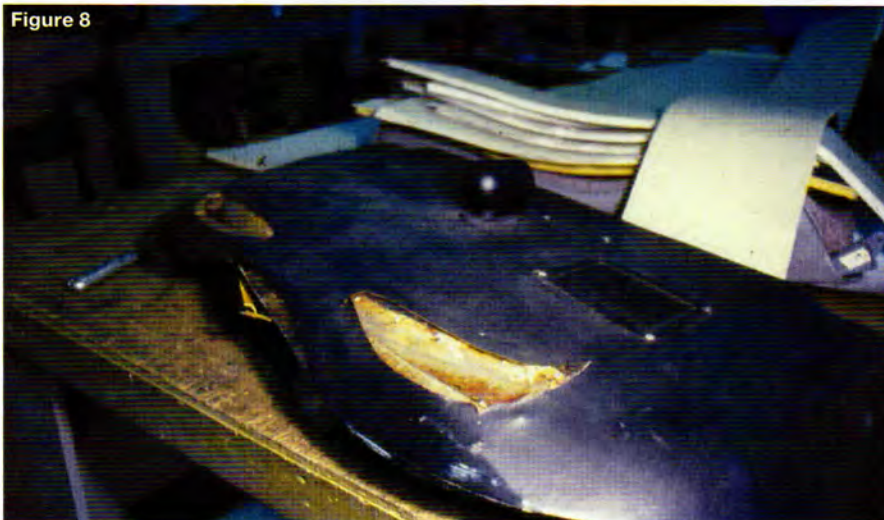
Figure 8

The glareshield is now ready to be covered with French-stitched black flame retardant vinyl (**figure 7**). I do not recommend using any vinyl that is light in color. If you do, you will be able to log all of your flight time on sunny days as actual IFR, as the sunlight reflecting off the glareshield onto the windshield will restrict your vision. Also, do *not* cover a glareshield with leather. As we've seen when used on window frames, leather shrinks as it ages and will deform the glareshield over time (**figure 8**). That photo says it all!

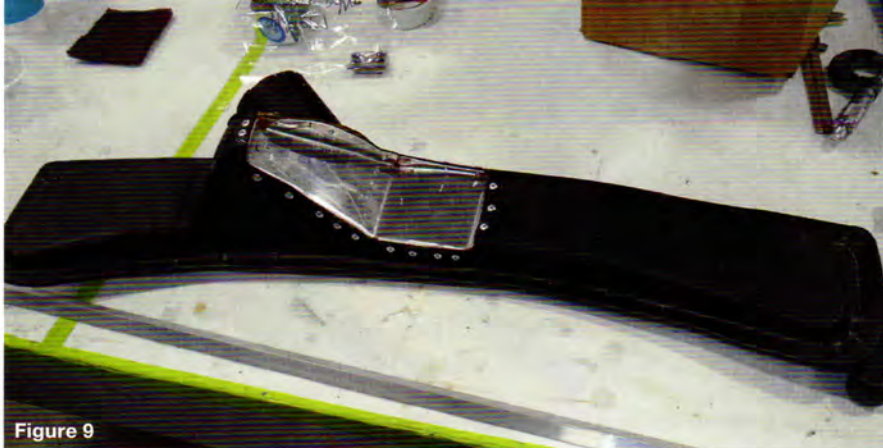
Figure 9

I'm going to move away from this ABS project to touch upon two other fairly common problems that we did not find in the ABS/ASF A36. The first is clearance issues with the defroster plenum. Some new avionics installations in Bonanzas and Barons can interfere with the defroster plenum; we've seen it all too often. Improperly executed field modifications done to these defrosters, using duct tape, hot glue, etc., can fail, causing hot air to blow directly on those expensive, heat sensitive avionics...ouch! The fix is to cut out the defroster to allow for proper

component clearance, and then fabricate a formed 0.020" aluminum filler piece that is secured to the defroster with 1/8" pop rivets and sealed with high temperature silicone caulk (**figure 9**).
