What is CORRUSION?

PARTI

BY DENNIS WOLTER, AIR MOD CLERMONT COUNTY AIRPORT, BATAVIA, OHIO

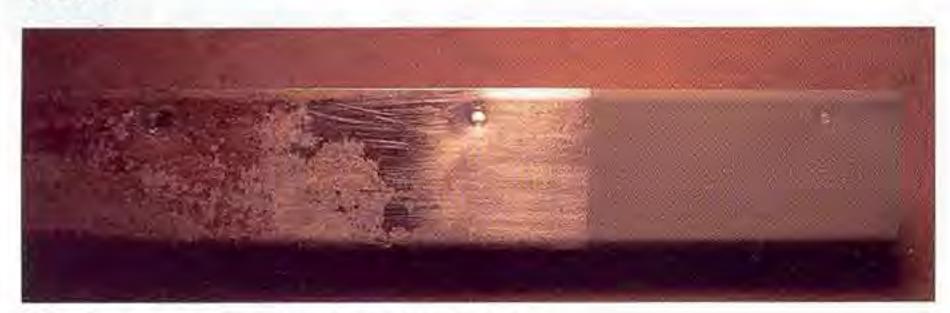
Corroded, cleaned, prepped and chromated

orrosion can be dealt with on three levels: One is prevention, another removal and the third is treatment, to slow it down or stop it. In certain difficult situations, the operative words are "slow it down." Our overall goal is to take a surface from one that is corroded, to one that is cleaned and treated, to one that is chromated. As illustrated in the photo of the aluminum seat sub-structure below.

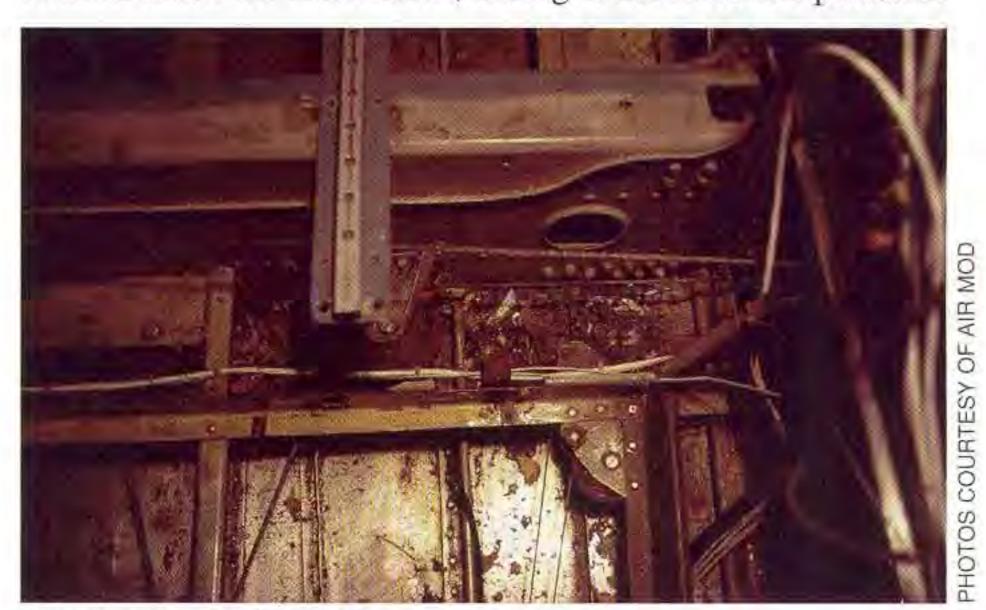
Typical mess under floorboards

Gain access to the affected area by removing interior components, floorboards, inspection panels, etc. Before applying any combustible solvents, you must remove the years of accumulated dirt and grime using a brush and vacuum cleaner, paying particular attention to the belly skins below the floorboards. Most Beech airplanes that we see are not well-cleaned below the floorboards, adding to the corrosion problem.

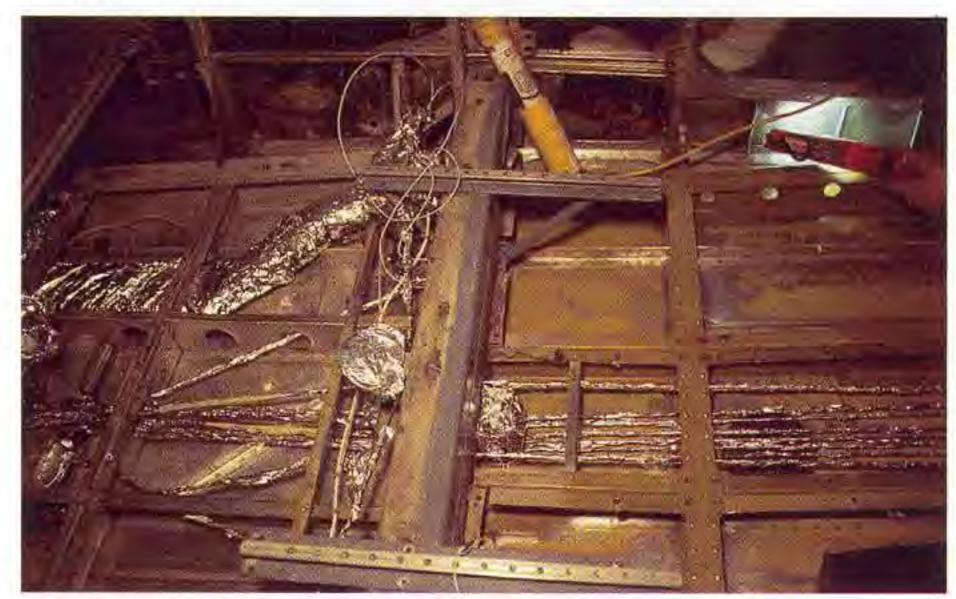
Preliminary cleaning and masking of belly

Once the dirt is gone, remove old insulation and sound-damping tar as necessary. You must now protect all sensitive components. I recommend using aluminum foil for wrapping wiring and cables, and polyethylene sheet and masking tape to protect autopilot servos, landing gear relays, windows, instrument panel, etc.

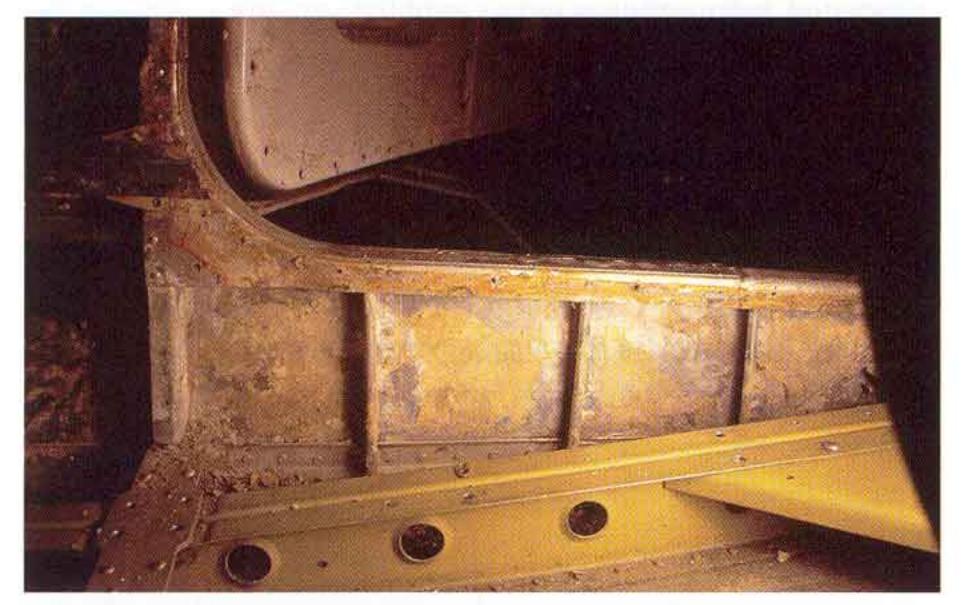
Corrosion under glue, below baggage door

In Beech aircraft, the problem is compounded by how difficult it can be to get rid of age-hardened contact cement used to install the insulation. It is vital that this glue be removed as we have found that corrosion can often form on the skin under the glue, especially around leaky doors and windows.

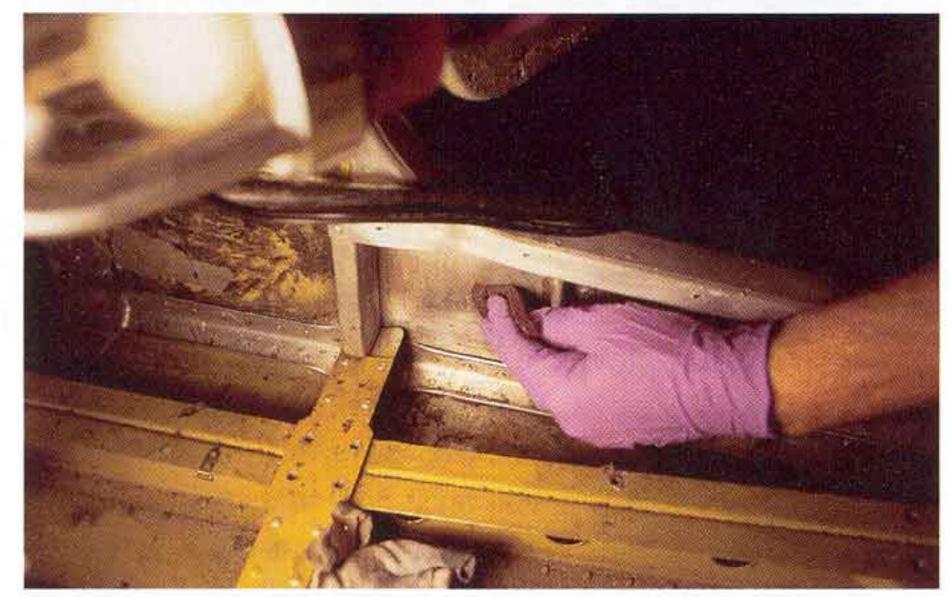
Scrubbing with Scotchbrite and lacquer thinner

Once this mess is cleaned up, all skins are cleaned and re-cleaned with mineral spirits or lacquer thinner until they are shiny and bright. Then the nitpicking process begins, cleaning all the nooks and crannies and lap joints with a sharp awl, toothpicks and compressed air. We then do a final cleaning with Prep-all contaminant remover.

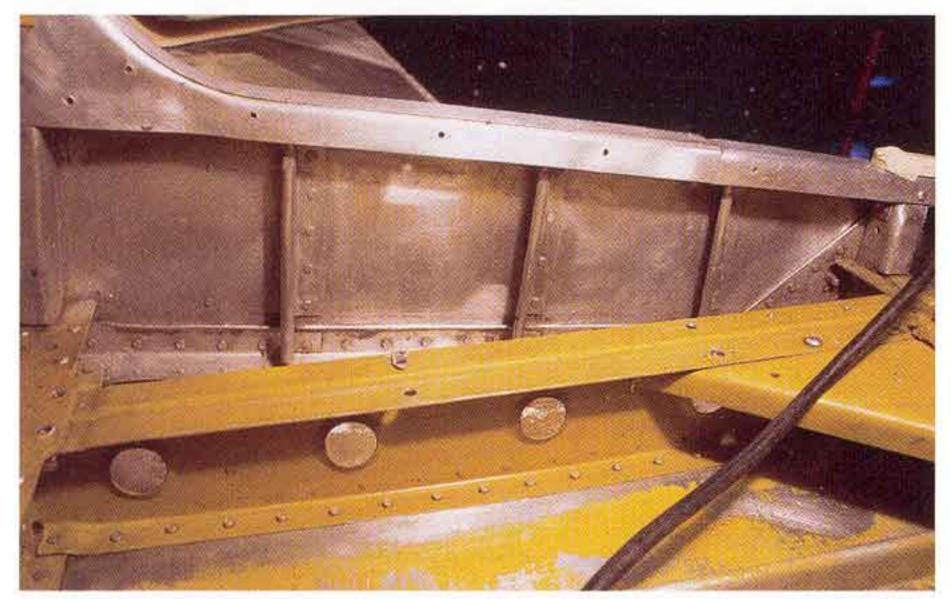
It's got to be this clean

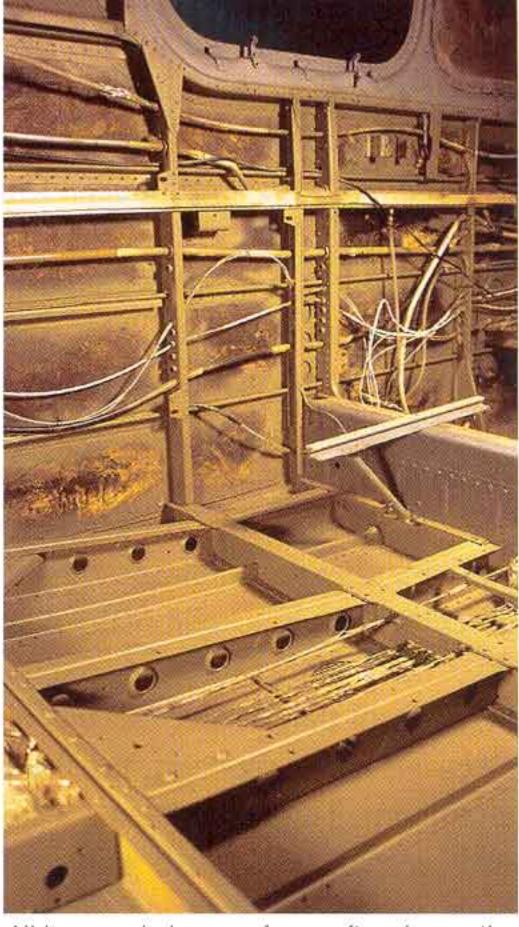
All bare and clean surfaces after chromating

When the surface is finally antiseptically clean, we spray the self-etching zinc chromate on all bright metal surfaces, being careful to avoid the factory-applied black damping material mentioned above. Remember the safety precautions when using zinc chromate.

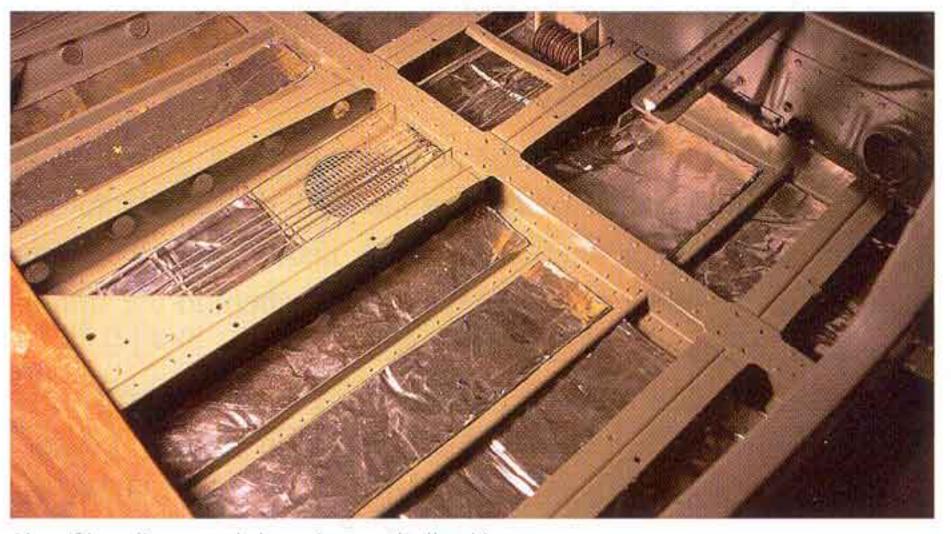
New Skandia sound-damping on belly skins

Note: In situations where we have removed the sound-damping tar material from the belly skins, we replace it with the installation of Skandia ADC-124 closed-cell self-stick foam—works great!

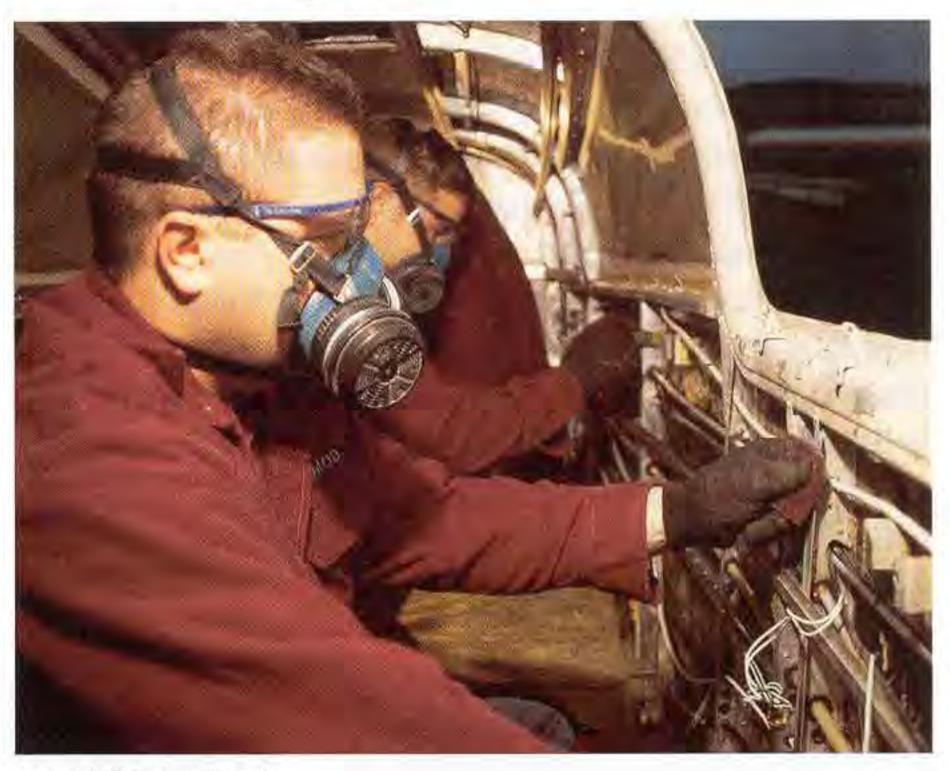
Lots of dirty, hard work
