New Glass - Old Panels

by Dennis Wolter

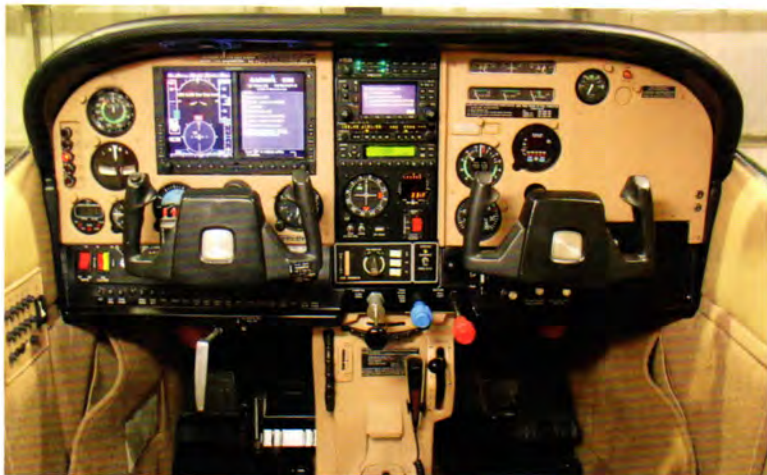
Cosmetically renovated 210 panel, modified to accommodate a Garmin 500 system and more.

Each installation is totally custom, with no two panels in any model being the same. Vacuum forming an entirely new overlay would be a costly process involving complex tooling, so we've developed a method of locating a large rectangular cut-out in the plastic overlay and bonding a 1/4" acrylic lip to the back side of the overlay. We then use 80-grit sandpaper bonded to a paint stick to hand sculpt a finished radius to the new cut-out, resulting in a hole that looks like it was molded into the overlay at the factory. Apply a little filler and primer and you are ready to paint.

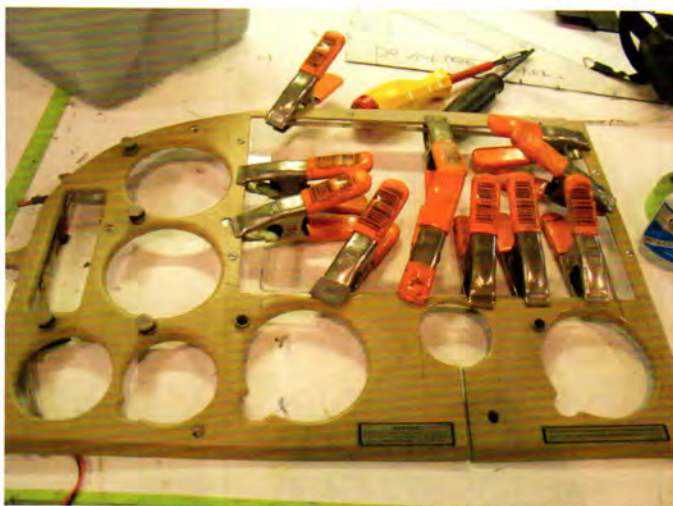
1/4" acrylic doubler being bonded to the original plastic overlay.

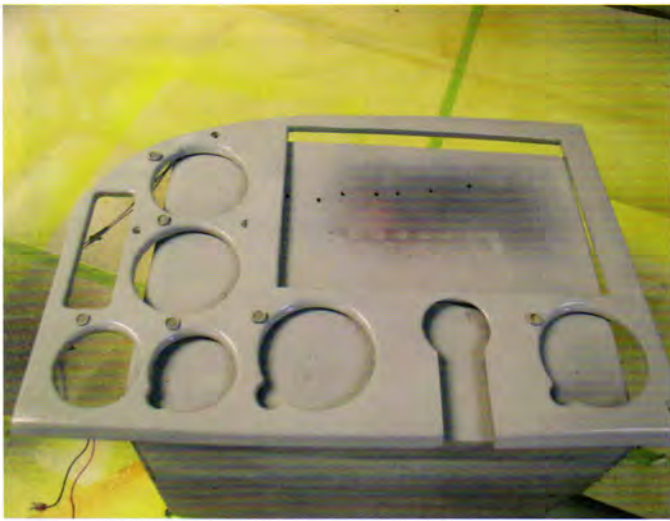
The panel overlay is sanded, filled, primed and ready for paint.

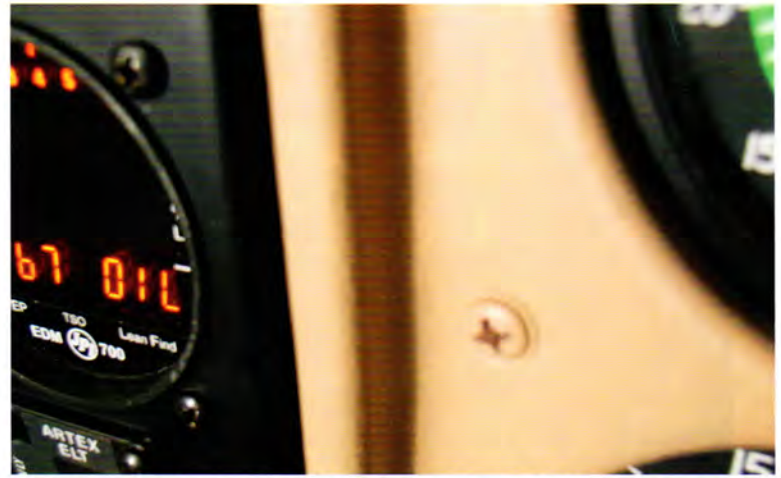
Painted finish screw and washer. Looks good, holds firmly and is easy to install and remove – wow!

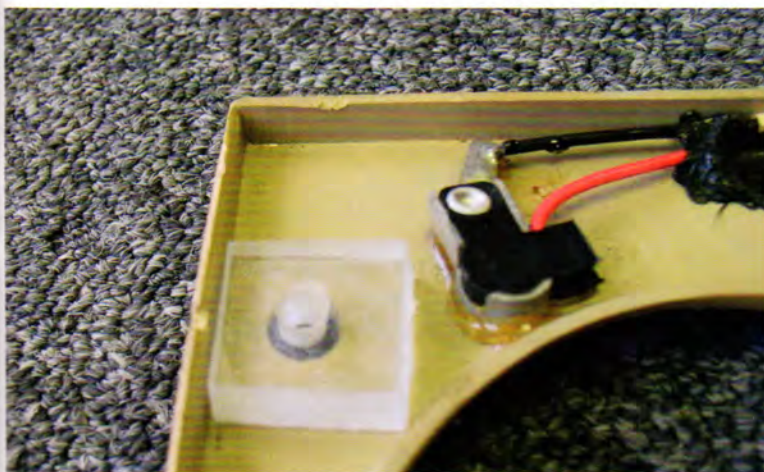
1/4" acrylic mounting screw doubler bonded to the back side of the panel overlay.

No plastic panel overlay discussion would be complete without getting into mounting issues. Except for perhaps the use of bubble gum, Cessna has tried every way imaginable to secure these panel overlays. For over thirty-five years we’ve tried and tried to improve on every one of Cessna’s previous systems. The real fix is to remove the original mounting hardware and install an 8-32 riv nut in the metal subpanel. Then locate a 5/32" hole in the panel overlay on the center of the riv nut, and bond a 1/4" thick 1/2" x 1/2" acrylic spacer over the hole on the back side of the overlay. Go to the front side of the overlay and drill a 5/32" hole through the 1/4" thick spacer. Finally, carefully countersink the finished side of the overlay to accommodate a #8-32 Auveco finish screw and #8 Auveco flush upholstery finish washer. You now have a fool-proof, secure and aesthetically pleasing mounting system for the former flimsily mounted panel overlays. Don’t be shy about adding some additional mounting screws where needed; we do it all the time.

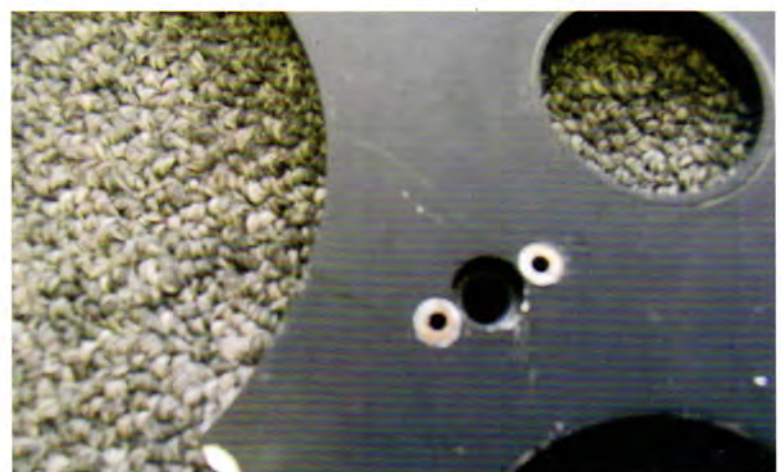
An 8-32 nutplate installed in an oversized hole.

tic pin that mated to a rubber grommet and hole in the metal instrument mounting panel. This hole for the grommet is too large for an 8-32 rivnut, making it necessary to install an 8-32 nut plate on the back side of the instrument mounting panel centered on the original oversized hole. This takes a little more time, but is definitely worth the effort.

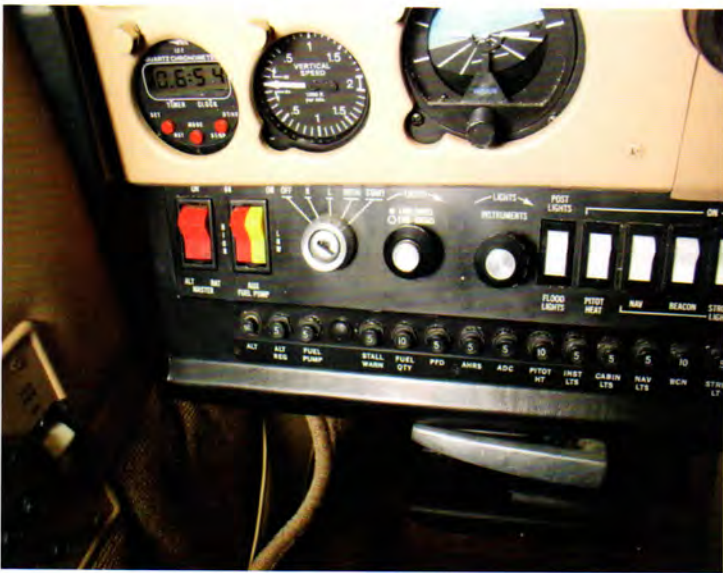
Repaired, re-painted and placarded sub-panel with removable circuit breaker placard strip.

Here is a big time saver that will allow you to avoid the tedious process of placarding all of those circuit breakers while in an awkward position in the airplane. Fabricate a .040" aluminum strip that is mounted with three or four short 4-40 countersunk machine screws tapped into the aluminum sub-panel structure. Paint and placard this strip out of the airplane. Any future changes to the placarding is a snap; just remove the strip and make the change.

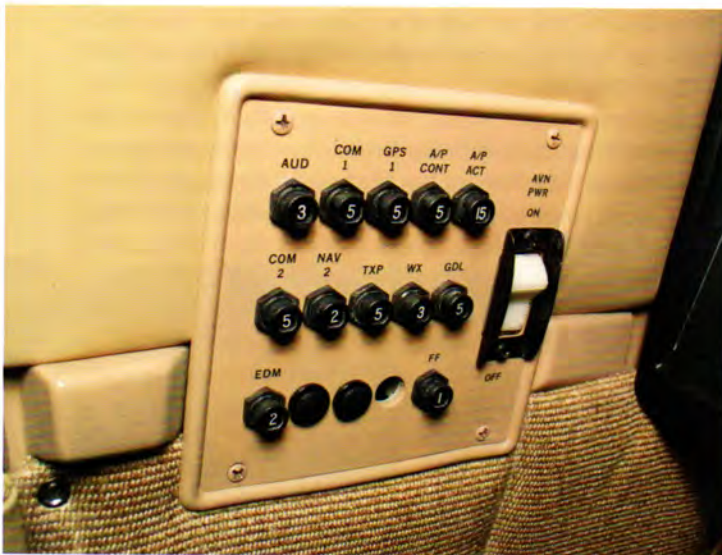
Renovated side panel circuit breaker panel.

The pedestal and side panel circuit breaker panel are removed, repaired, painted and placarded using the same methods as used on the instrument panel overlays and sub-panel components housing controls and circuit breakers.

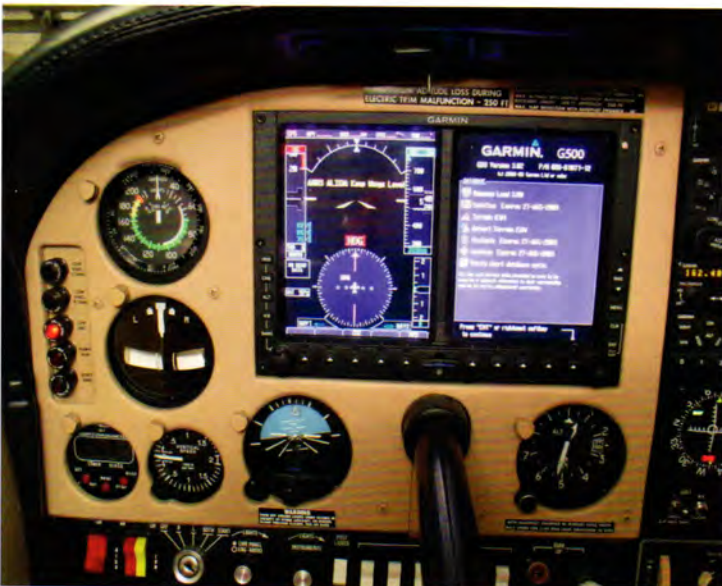
Close-up of the renovated panel with the Garmin 500 installed.
