Renovating the ABS/ASF Bonanza

Part II: Making Progress

By Dennis and Cynthia Wolter

Last month we began this series on the work Air Mod has done on the ABS Air Safety Foundation A36, which gave us a first look at what was underneath the interior of this typical 36-year-old Bonanza. This month, Air Mod gets to work on the repairs.—ed.

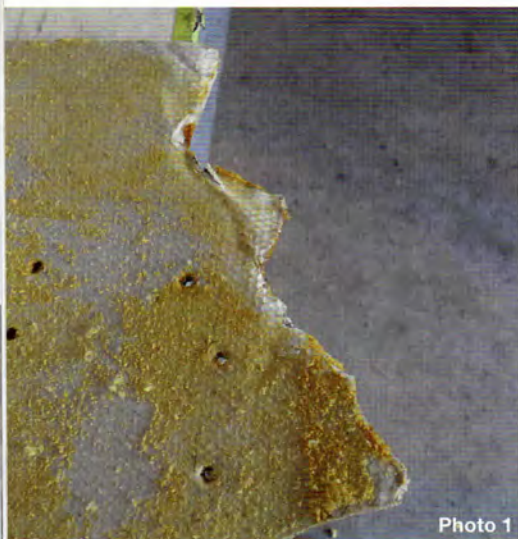
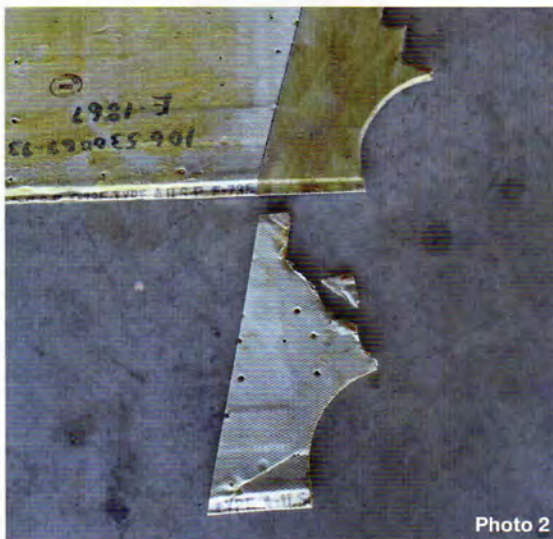
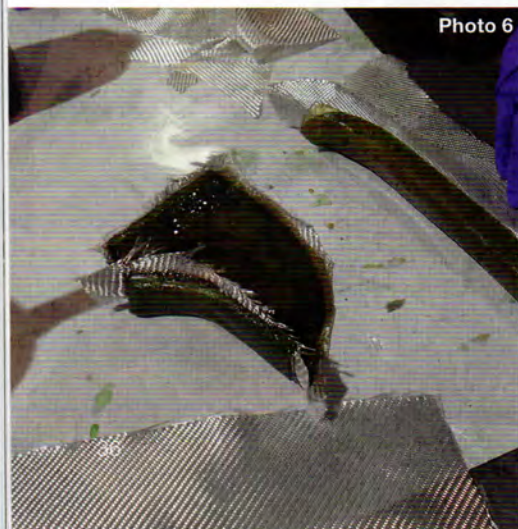
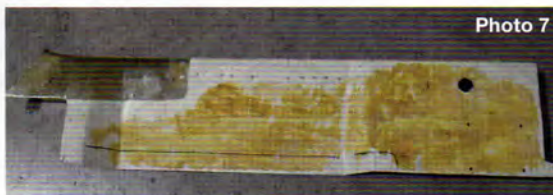
We begin with side panel repair and modification. To save weight and money, Beech fabricated the cabin side panels using very lightweight, delicate, and easily damaged honeycomb material. They then fabricated a one-piece left side panel that is just over 13 feet long. Removing and reinstalling this piece requires a great deal of care. Guess what happens: These panels are almost always damaged (**Photo 1**).

N3819M was no different. The fix is to splice on a new section of honeycomb

trimmed to fit to precisely meet the contour of the instrument panel and the fresh air outlet. To eliminate future damage to the delicate forward edge of the repaired panel, we bond 0.020" aircraft aluminum to the back surface of the side panel, greatly enhancing the durability of the panel (Photo 2). The second step is to cut the long side panel into three manageably sized pieces. One cut is made at an angle, at a location that hides the splice behind the back of the pilot's seat, at which point we install a Velcro-lined support brace (Photo 3). The second cut is made at the aft end of the panel at the leading edge of the cargo compartment step-up (Photo 4). These modifications make it easier to remove and reinstall the left side panel when accessing wiring, oxygen, and pitot static lines. This ensures when you get your airplane back after an avionics installation or a maintenance event, your interior will not be damaged.
