Renovating the ABS/ASF A36

Part 9: Finally—Interior Installation

By Dennis and Cynthia Wolter, Air Mod

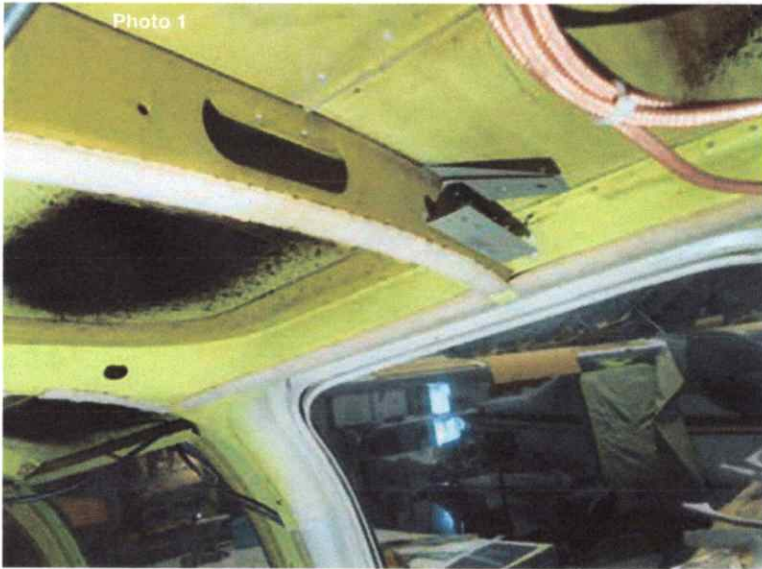
Photo 1

factory mounting brackets (parts 58-530139-3 and -4) on an existing heavy bulkhead that runs spanwise across the top of the cabin (**photo 1**). Back in the early 1970s, Beech included these brackets in all 33, 35, 36, 55, and 58 airframes, whether four-point shoulder harnesses were requested or not. If you have an early '70s Beech airplane and want to install the BAS four-point harness system, look for a pattern of nine rivets on the cabin top above the center opening cabin windows (**photo 2**). Having these brackets already installed will reduce the cost of the four-point harness installation by about \$1300, and eliminate the need for having to obtain a field approval.

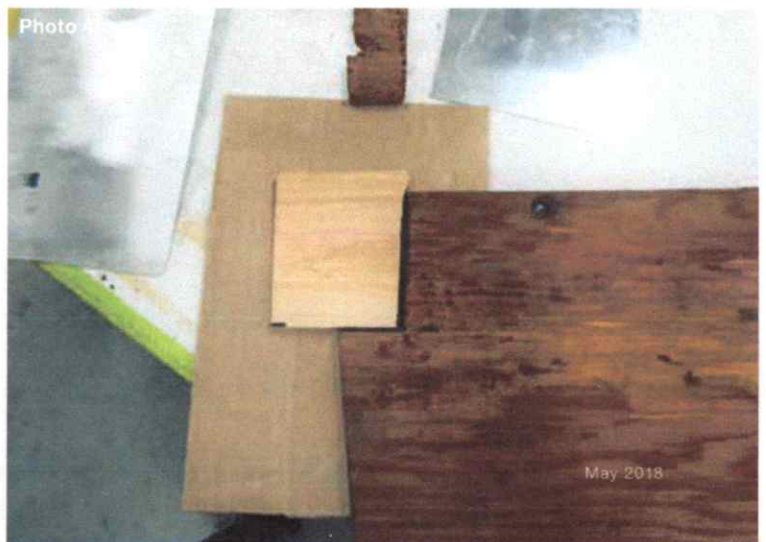
Photo 4

Another common issue we had to fix involved mounting holes that, over time, became enlarged or broken out, particularly at the corners of the floorboards. The fix here is to first splice a new piece of epoxy-bonded wood at the damaged area (**photo 4**), reinforced by a .016" aluminum plate bonded to both sides of the floorboard (**photo 5**). We then locate and drill a new mounting hole, and the floorboard is as good as new.

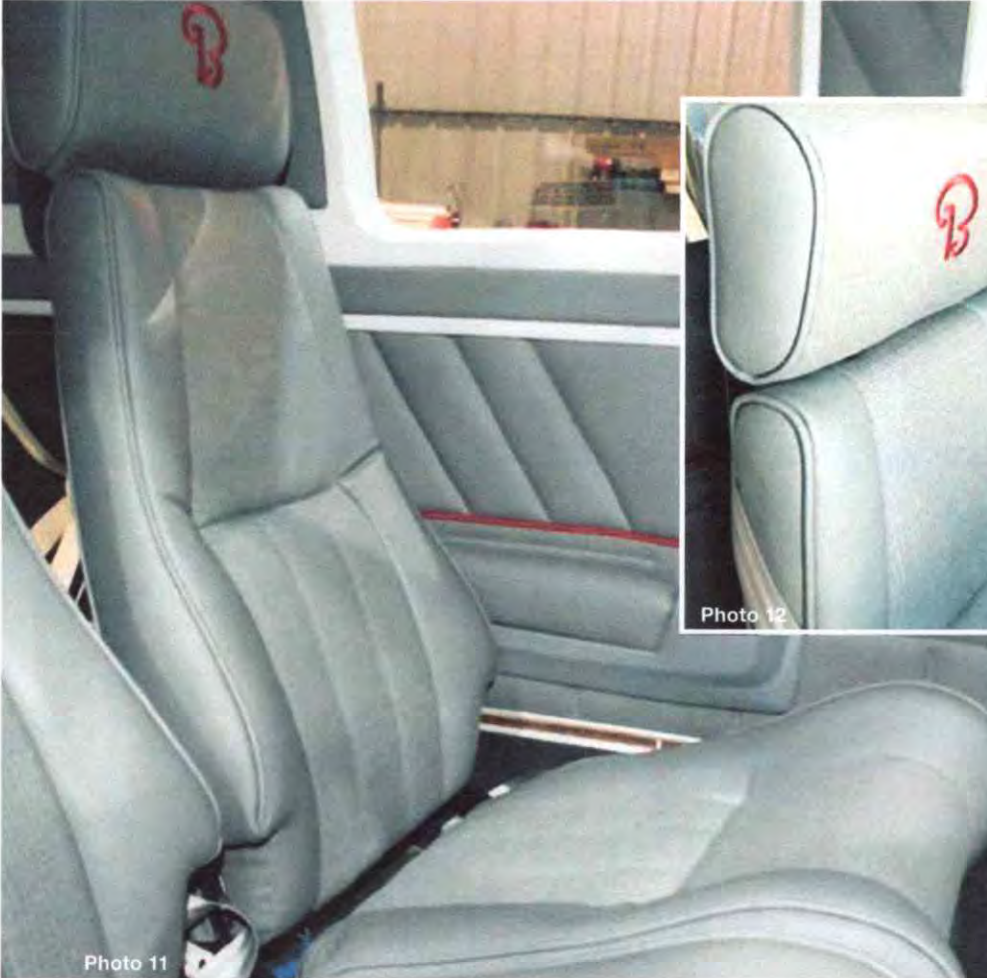
Photo 11

With the completion of some of these less-than-glamorous details, the fun part begins. After weeks of detail work, repairs, and problem-solving, we are rewarded with the visual transformation that comes with a few days of final assembly. We installed the newly renovated side panels, headliner, and windlace cord, followed by the Velcro-mounted carpet and the renovated seats (**photos 11 and 12**). The job is finished!
