Renovating the ABS/ASF Bonanza

PART III: HEADLINER

By Dennis and Cynthia Wolter

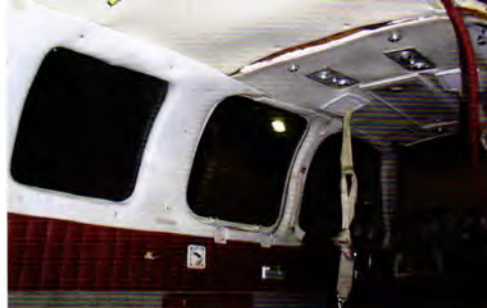
Photo 1

To properly repair and reupholster these headliners, it’s important to understand why they were designed and fabricated as they were. The previous iteration of Beech headliners installed in the 1970s was a two-piece, semi-rigid urethane foam design that is prone to sagging and shrinking when exposed to temperature cycles (Photo 1). They also had a complicated and not very efficient fresh air ducting system. Beech engineers solved these problems by designing an entirely new headliner with a larger and more efficient fresh air duct system, fabricated of thermally stable and lightweight molded honeycomb material. To include as much head room as possible and incorporate a large air duct, Beech lowered the center of the headliner, creating a convex shape running the entire length of the headliner. As often happens when solving one problem, another is created. As the finish vinyl bonded to these headliners ages, it begins to shrink slightly. At the same time the foam backing material begins to disintegrate, causing the two materials to pull away from the concave areas at the edges of the convex fresh air duct. This eventually leads to the sagging headliners we’ve seen all too often in later Beech airplanes (Photo 2).

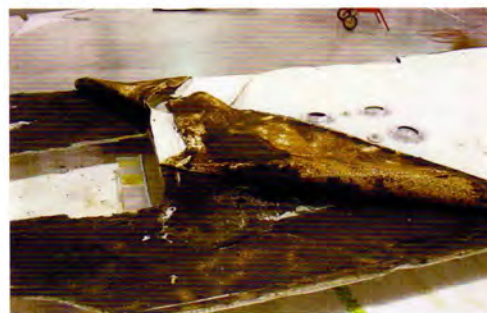
Photo 3

related pieces removed (lights, nozzles, etc.), it’s on to removing the existing finish material, foam, and adhesive. If the headliner still has factory original materials, you must first peel off the vinyl finish cover and degraded black foam (Photo 3). With that mess removed, strip the remaining clear adhesive. Our method is to soak towels in lacquer thinner, lay them on the adhesive, and then cover the headliner with plastic to allow the thinner to start dissolving the adhesive (Photo 4). We use plastic scrapers to carefully remove gross amounts of this tenacious adhesive. It’s very important to not damage the delicate composite honeycomb substrate (Photo 5). The final cleanup step is to use pieces of old carpet soaked in thinner to totally remove all the old adhesive. Unlike rags, the open pile of carpet acts almost like a brush and doesn’t readily load up with the old adhesive. It works great and it’s free!

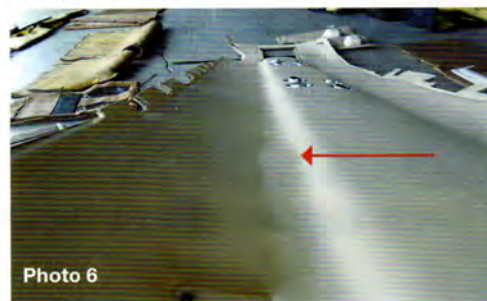
Photo 6

The ABS Air Safety Foundation’s 1981 A36 had a replacement headliner recover job that was in the early stages of delamination and was beginning to separate in the concave areas of the headliner (Photo 6). To prevent separation of the finish vinyl and backing when this existing headliner was installed, very firm foam had been heavily glued to the composite substrate (Photo 7), then

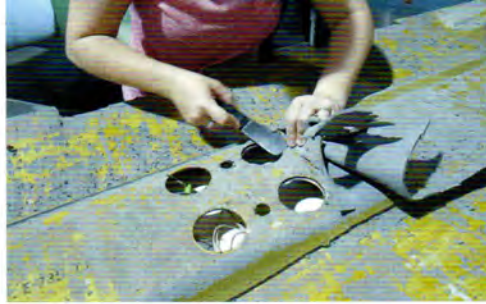
Photo 8

the finish vinyl was bonded to the foam with a very tenacious adhesive. This made removing these materials a difficult challenge. We had to carefully cut the foam off the surface of that delicate composite substrate using a sharp putty knife (Photo 8). We then soaked the remaining foam residue and adhesive with terrycloth rags doused with lacquer thinner, as mentioned earlier. This allowed us to use carpet to safely clean the glue off the substrate without causing damage to its surface. This process took a patient and careful person eight hours to complete.

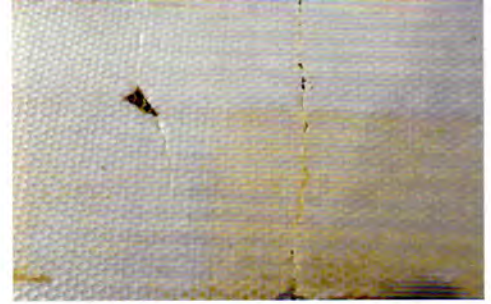
Photo 9

Once we're finished with the cleanup process, the next step is to repair any cracks or deformations in the composite structure (Photo 9), a process we described in the July 2017 article on side panels. We then addressed the frustrating results of a shortcut taken by the factory: holding the threaded mounting rings for the reading lights in place with RTV silicon sealer (Photo 10). This pipe dream solution frequently allows the mounting rings to separate from the headliner substrate any time a light is removed. This makes it almost impossible to reinstall a light without having to completely remove and disassemble the headliner. A six-hour job: ouch! The fix is to remove the reading light mounting rings, clean off all of the old silicon adhesive, and re-mount the rings with $\frac{8}{32}$ " machine screws and self-locking nylock nuts. We then seal the outer perimeter of the rings with thick Polyfix™ adhesive.

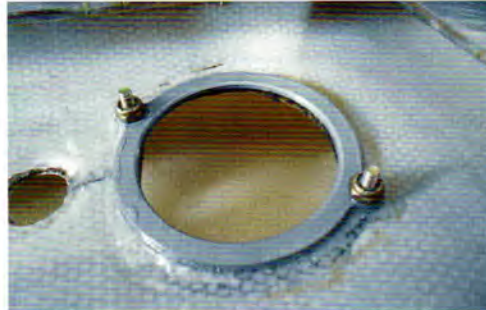
Photo 11

The next improvement we make is to secure the threaded fresh air vent nozzle mounting rings with thick Polyfix™ (Photo 11). These rings do not have mounting flanges so they must be thoroughly cleaned before bonding with Polyfix™.

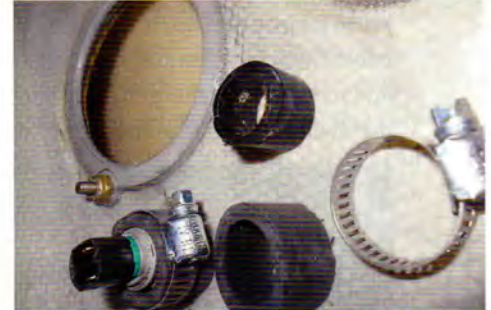
Photo 12

The next issue facing us was how to mount the reading light switches, so as to have access to them and be able to remove them in the future as they are prone to failure. With the air vent nozzle mounting rings now properly secured, we simply unscrew the nozzle and reach through the mounting hole to remove the light switch. The switches were originally secured in a delicate plastic locking collar that is most likely already damaged, or likely will

be damaged by even the most careful technician trying to remove the switch. A simple and durable fix is to slide a piece of rubber hose over the body of the installed switch and secure it with a small screw clamp. We orient the screw head of the clamp so the switch may be unscrewed and removed from the air vent hole. The picture shows the old, unusable plastic collar and the hose and clamp (Photo 12). No more need to remove the headliner

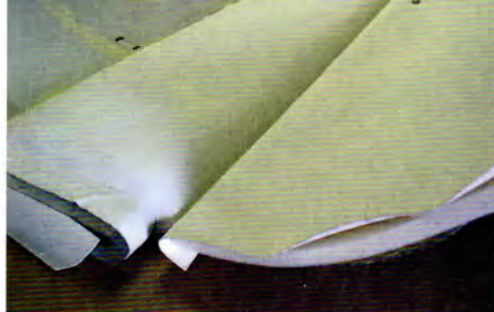
Photo 14

Here's the good part: To eliminate any possibility of future separation of materials, we physically secure the finish material at the lowest point of the concave area along the entire length of the headliner. This is done by fabricating full-length, 1" wide, 0.040" thick strips of aluminum, drilled and countersunk every 1 1/2 inches (Photo 13). These mounting strips are bonded to the outer headliner finish material, secured with #4 countersunk upholstery screws and flat Tinnerman nuts. Next we bond 1/2" soft urethane foam to the outer headliner substrate. We then pull the finish material outward and wrap the edges of the headliner (Photo 14). The final result is a securely installed, clean-looking, durable headliner that will never sag (Photo 15).
