# INTERIORS

## THE INSIDE STORY

### PART VIII

BY DENNIS WOLTER  
AIR MOD, CINCINNATI, OHIO

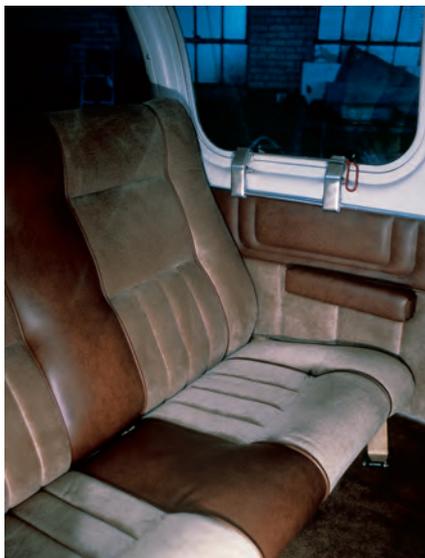
First generation side panel system.

I consider the first generation of side panel/headliner design as being those installed in the 1947 straight 35 through the 1952 C35. Both were large form-cut flat panels of .016" 2024 T-3 aluminum. These panels were covered with thin fiberglass padding and wool fabric, with leather on the armrests and upper side panels. A minimal amount of topstitching was used for some surface design and material support. The armrest of the day was a '40s Studebaker-looking screw-on job. Very quaint!

These panels were held in place by standard 1/8" diameter aircraft rivets located at the panel's edge. This sounds great in concept, but Beech used an automotive spring steel receiver clip to hold the rivet in its corresponding

mounting hole in the aircraft's structure. When new, this system worked great, but let a little corrosion develop between the steel clip and the aluminum rivet and it became impossible to remove the side panel or headliner without damaging the thin aluminum backing panel.

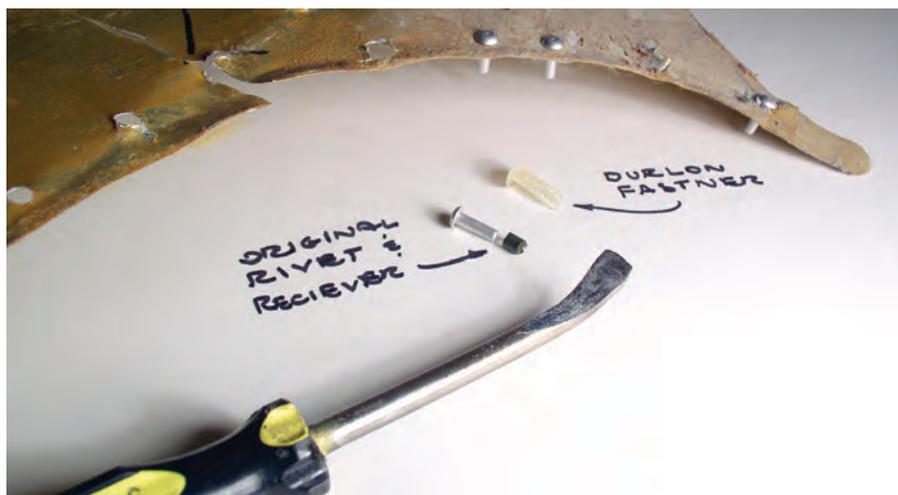
Typical side/headliner panel, original rivets and new durlon fasteners. Note handmade tool in foreground.

We use a homemade tool fabricated

from a cheap screwdriver to help reduce the damage to the upholstery panels caused by these stubborn fasteners. Don't even consider reusing these bad boys.

Fortunately, in the early '60s Beech came up with a durlon push fastener that fits the original holes, holds well and releases easily, making damage-free

removal and reinstallation of the panels a snap. Even with the durlon fasteners, I still use my homemade tool to assist in removal. You can never be too careful.

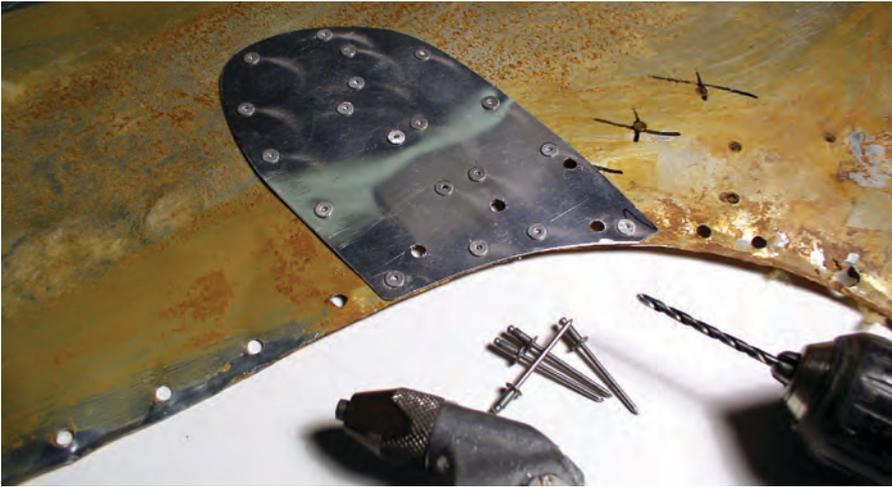
Typical torn aluminum panel repair.

The second most common problem is a tear at the metal's edge. Here a scarf or overlay patch is the fix. We use soft 1/8" hardware store pop rivets and twenty-thousandths 2024 T-3 aluminum. The photo above says it all. We often tap the installed pop rivets with a light hammer and then sand or file the protruding heads down to a minimum to keep the repair from showing through the new upholstery.

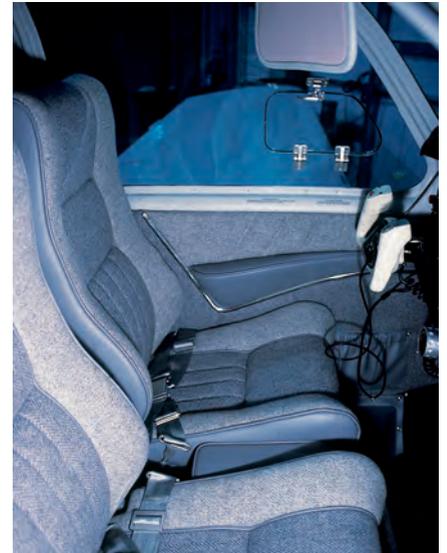
Second generation of side panels with a molded armrest and stainless steel trim molding.

The second generation of Beech airplanes, 1953 F35s through 1960 M35s, had the very classic-looking, somewhat sculpted armrests with a blind-mounted stainless steel accent molding. The problems found in the earlier side panels and headliners apply also to this generation of interiors, including replacing the aluminum mounting rivet with the later durlon fastener.

There are two problems with the armrests, however, that are unique to this group. First is how Beech attached the stainless steel trim strips. In order to blind-mount these strips (no visible mounting hardware), thin steel tabs were wedged into the back side of the stainless strips. These tabs often break off as they are straightened when the strips are removed or as they are being rebent when resealing the strips after new upholstery has been applied.

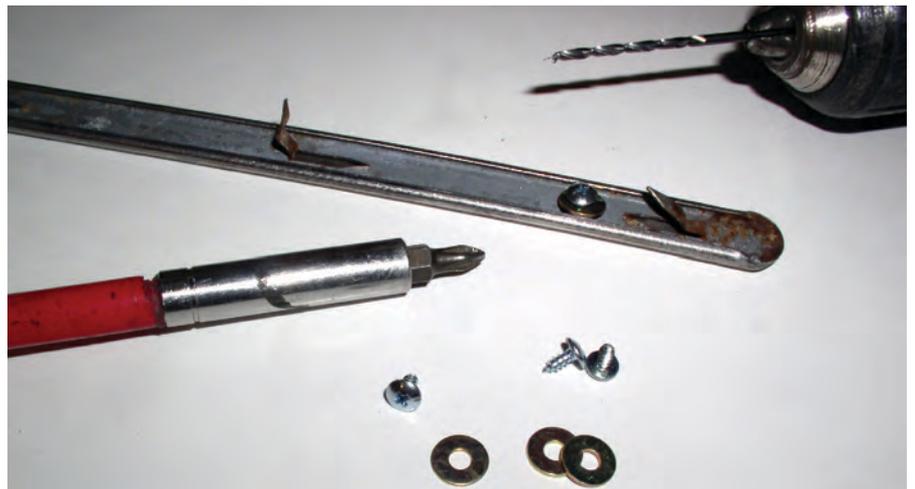
These #4PK screws and washers hold better than the original delicate mounting tabs.

Not to worry, a good fix is at hand. Using a #43 drill bit, drill a hole through the side panel into the steel tab strip. Be careful not to drill into the stainless molding. Then secure the trim strip with short #4 PK screws. This is a good thing to do even if all the original mounting tabs have survived previous removal and reinstallation.

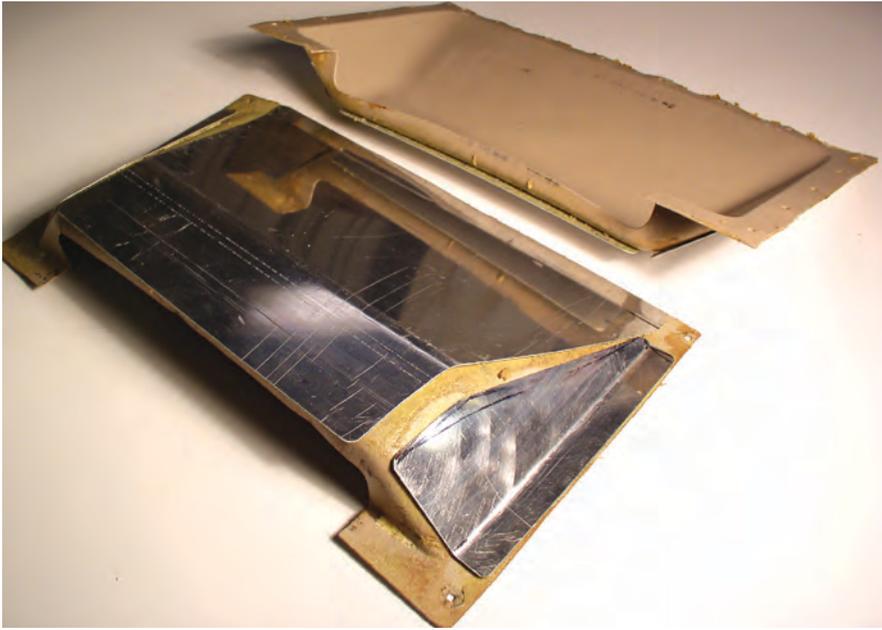
Reinforcement of armrest recession pans.

Armrests used in this generation of side panels, although somewhat dated in appearance, are extremely well made and rarely require repair. That said, the vacuum-formed pans that form the pilot and copilot armrest recessions were made from that insidious royalite vacuum-formed plastic and are almost always warped. They will need to be heated and reformed back to their designed shape, and reinforced with aluminum so they won't warp in the future. I repeat: I hate that plastic stuff!

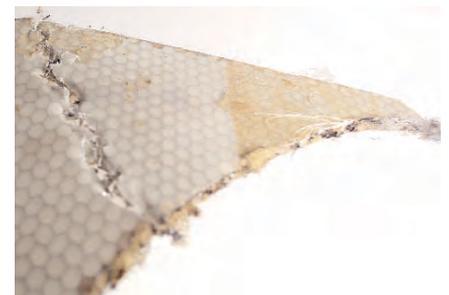
Cracked corner of honeycomb side panel.

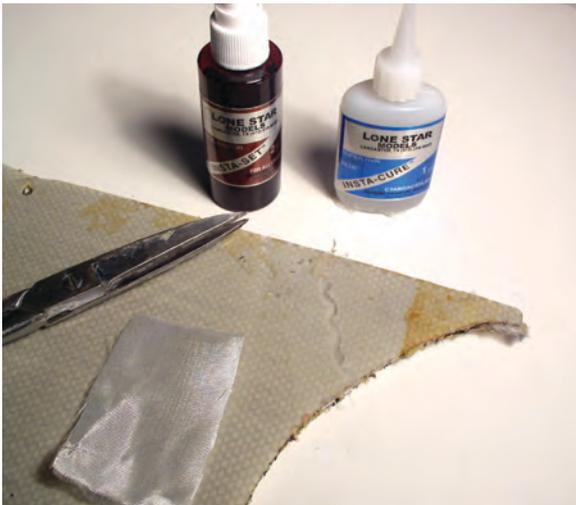
Repaired crack.

*For tear or crack repairs*, place the panel in question on a flat surface and thoroughly clean the damaged area. Cut a piece of the model maker's fiberglass to conform to the shape of the damaged area. Apply the adhesive and spray on the instant-curing accelerator. Then flip the panel over and repeat the process on the opposite side and the repair is complete. Be sure to wear rubber gloves and a charcoal mask, as this adhesive is very unhealthy stuff.

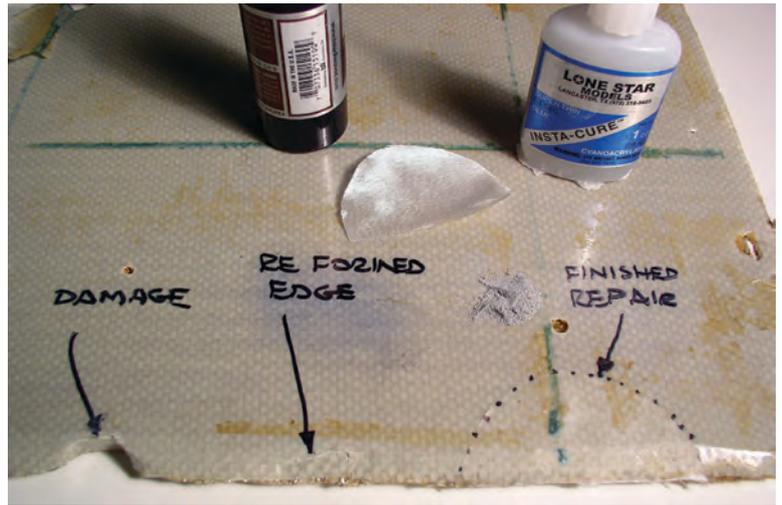
Repairing a crushed edge.

*Crushed and torn edges* must first be formed back to their designed shape. Then apply the fiberglass cloth to one side as described above. Trim the thin cloth to the desired shape with scissors. Use a plastic filler powder to fill in voids (ground-up acrylic works well) and apply some adhesive. Next apply a second layer of cloth to the opposite side. Trim the edge, do a little surface sanding, and this part of the panel is as good as new.

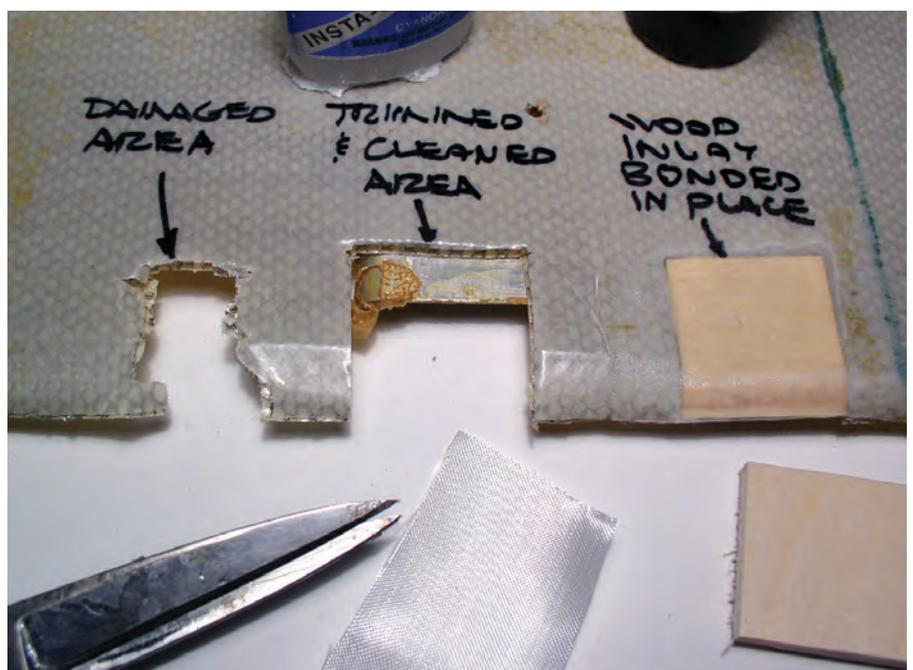
Grafting on a missing piece.

*Replacement of a completely missing section* is the last repair challenge.

At Air Mod we have the good fortune of having "donor" panels as a source of repair material to use for grafting on a missing piece. If you don't have this material available to you, go

to the hobby shop and buy balsa wood stock that is the same thickness as the original panel. Cut it to the required shape and overlay both sides of the repair with the model maker's cloth and adhesive. The repair will be light, strong and durable.
