INTERIORS

THE INSIDE STORY PART IX

BY DENNIS WOLTER
AIR MOD, CINCINNATI, OHIO

REPAIRING HEADLINERS

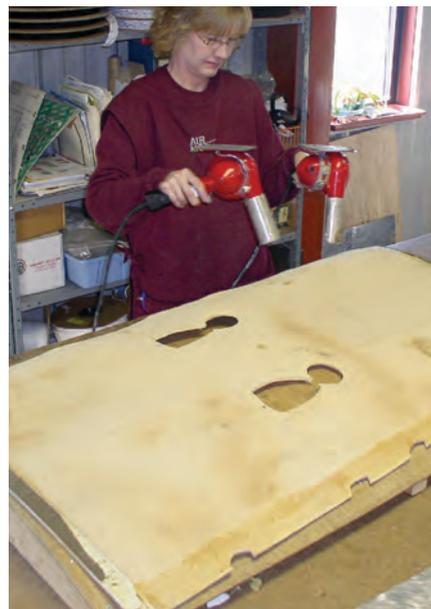
Reshaping the headliner panel on a wood form.

Wood formers and plywood assembled into an arc shape identical to the cabin top works great. With the panel placed on the wood form, heat is applied with heat guns until the material becomes soft. Then a sheet of .040" aluminum is form-pressed against the back side of the material, holding it evenly and firmly in place as the material cools and assumes its proper shape.

This process is repeated a section at a time until the entire panel is completely reformed to be as it was when new.

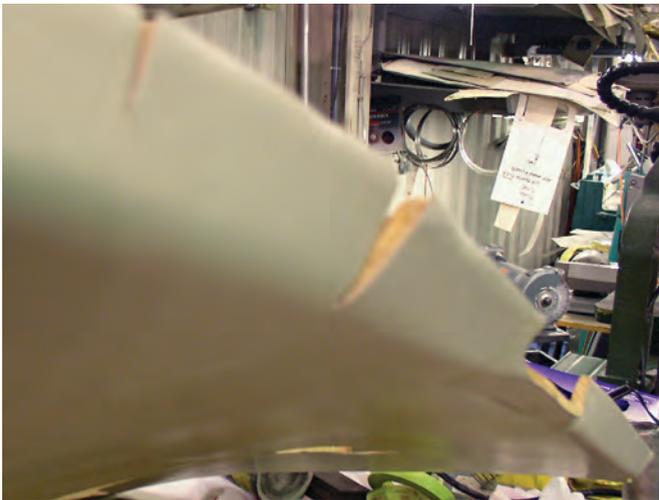
Typical cracking at the edge of an earliest generation plastic headliner.

First, the formed edges of the panels are often cracked or torn and must be repaired with the polyfix and fine mesh fiberglass process described in our side panel article last month.

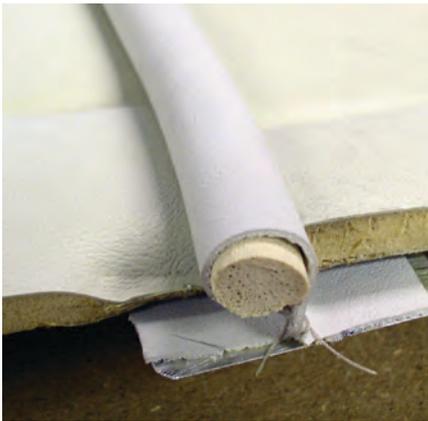
Gap-filling windlace strip.

Fabricate a 3-foot piece of windlace cord with two parallel stitches about 3/32" apart. Bond this to a 2" by 30" strip of .025" 2024 T-3 aluminum to create a standing bead of finished cording that can be slid in place to fill the gap. This cording material will expand and contract with temperature changes to create a pleasant-looking and permanent fill piece, eliminating the unsightly gap between the two large headliner panels. Sometimes you luck out. We've been using these techniques for 30 years and no failures to date!

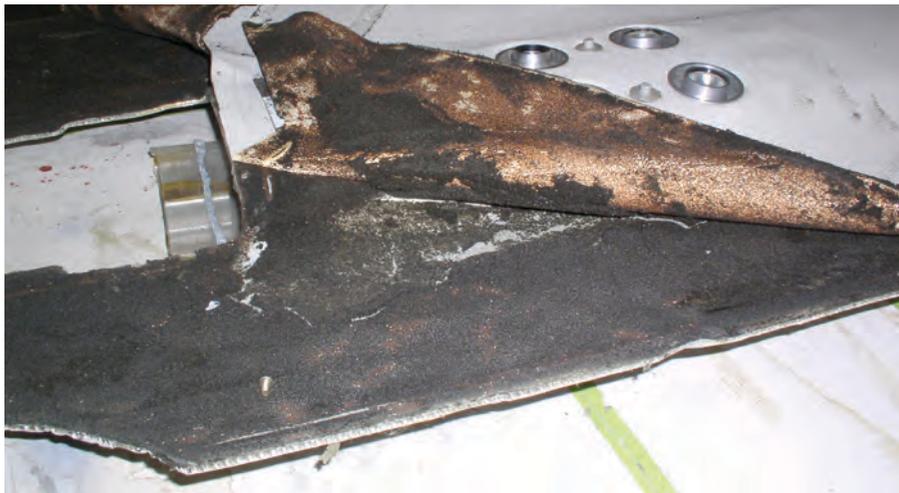
Typical mess caused by the bad backing foam.

In as few as three years, some of these headliner coverings will begin to fall down, leaving behind a mess of black degraded foam that has the consistency of warm bubble gum. Add to this a tenacious layer of goeey adhesive originally used to bond the material to the headliner, and you have about a six- to eight-hour clean-up job involving lots of lacquer thinner, rags, scrapers, abrasive pads and patience.

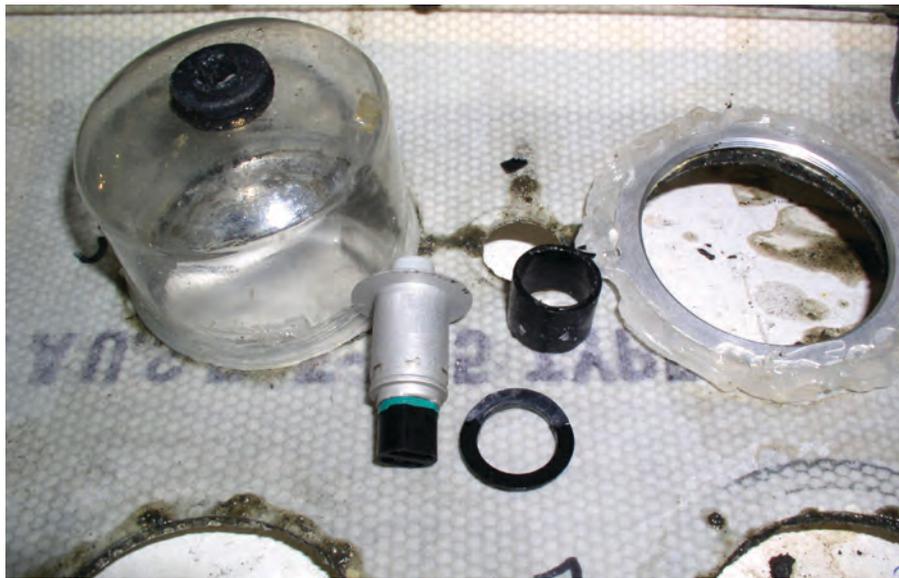
Poorly secured light and vent mounting rings. Note the broken switch retainer.

The *third* big issue with these headliners is the way Beech rather poorly secured the threaded rings that hold the vent nozzles and light fixtures to the headliner. By design, these rings were intended to be structurally secured to

the headliner with plates and screws, evidenced by the fact that they contain mounting flanges and holes. But to save time during assembly at the factory, Beech chose to glue them in place with a crudely applied bead of RTV silicon sealer—bathtub caulk, no less!

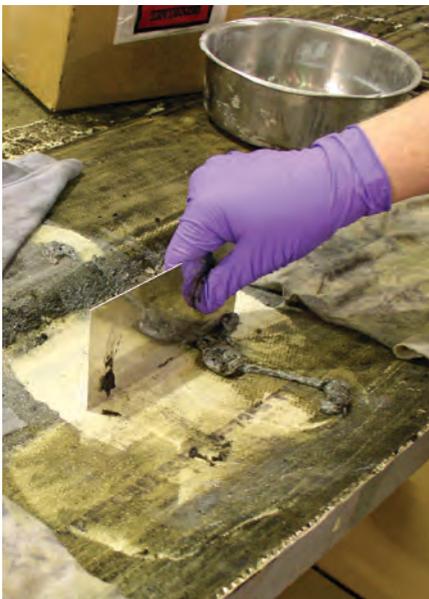
Scraping off the old glue residue.

Before applying any lacquer thinner, you'll need to scrape off as much of that degraded foam mess as possible. A 1½" wide thin putty knife seems to be the tool of choice for this. Now you're down to the obnoxious adhesive I mentioned.

Brush on generous amounts of lacquer thinner and also place thinner-soaked rags on, one section at a time. Let the concoction soak for five to ten minutes. You can move ahead and apply your soaked rags to the next area, and while they're in place, go back to the previously soaked section and start scraping.

We use about a 6" piece of .040" aircraft aluminum to doggedly scrape away the now somewhat-softened adhesive from the surface of the headliner. Hint: Use an old cardboard box as a repository for the old foam and adhesive because you'll never get that gunk out of your garbage can.

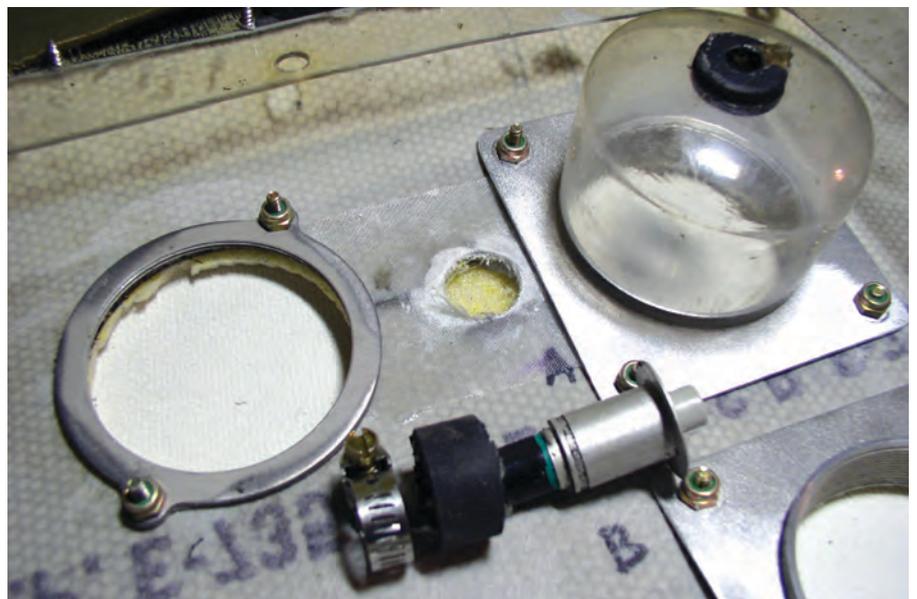
Properly secured light and vent outlet mounting rings. Note the low-tech, but effective, switch and mounting components.

Light & vent mounting rings—Now it's time to properly secure the light and vent mounting rings. The vent rings are the easiest to do since they have mounting flanges and holes at their outer edges. An 8-32 countersunk screw and self-locking nut, two holes and you're done.

The lights require the fabrication of a .050" 2024 T-3 aluminum mounting plate with an 8-32 sized hole at each corner and a precisely sized hole in the center that will seat against the flange on the light's mounting ring.

Push switches—One final mechanical issue is the way the push switches were originally installed. Most often the plastic mounting tubes are not reusable. A short piece of the correct diameter rubber hose and a small screw clamp will securely hold a pesky switch in place. If a switch needs to be removed in the future, just remove the adjacent air vent and loosen the screw clamp through the now open vent hole for easy access to the switch.

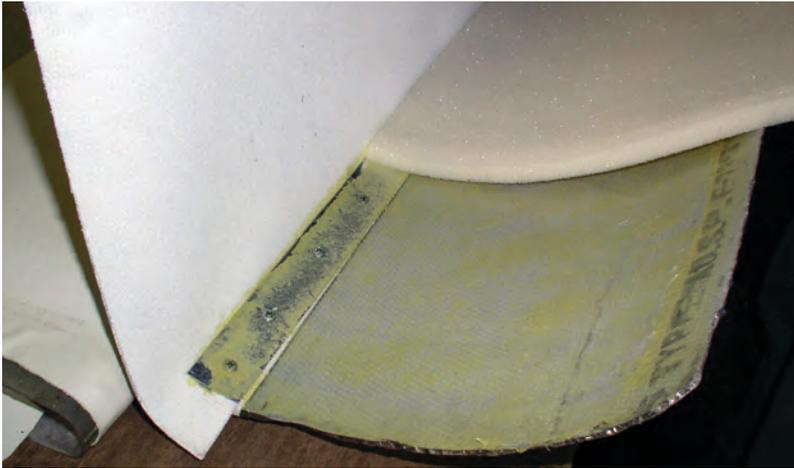
Inside curve retaining strips.

It's finally time to actually pad and recover the headliner. To eliminate the challenge of keeping bonded finish materials secured in a concave shape, we upholster the headliner in three lengthwise sections, foaming and covering the dropped center part first. We then bond a 1" wide full-length strip of .040" 2024 T-3 aluminum to the back side of the long edge of the outer cover material.

We secure the strip to the concave part of the headliner with about 60 #6 x

½" countersunk PK screws. We bond a layer of ½" foam to the headliner at the inner edge of the 1" retaining strips. Trim the foam and the outer edge and stretch the finish material outward, and *voila*, you have a beautiful blind-seam, structurally secure headliner that will never come loose in the negative curve area and never drop down.

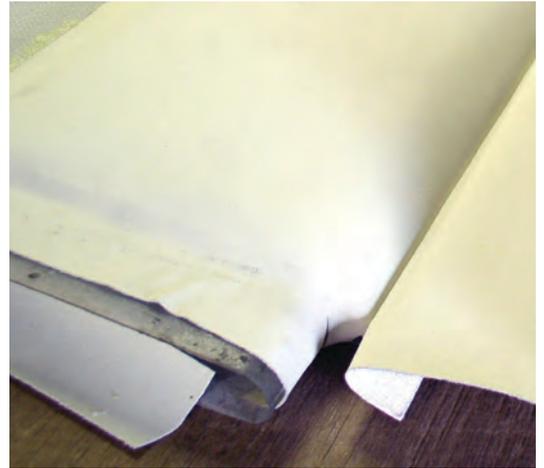
Finished seam along inside curve of both sides of headliner.
