Wing Tips

Door and Window Seals

We're finally at the beginning of our last "Wing Tips" article on the exciting topic of installing and adjusting door and window seals. This final installment will cover sealing aft cargo doors on A36 and Baron 58 models, as well as center opening window seals on all 35 through 58 models.

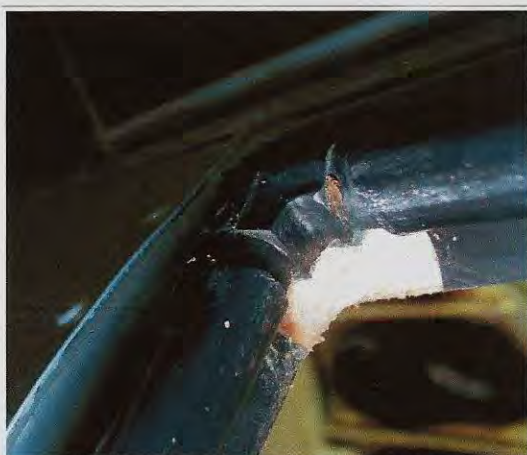
30 years of time has caused the corner piece to shrink and separate.

It's important to be aware of a couple of things when dealing with aft cargo doors on 36 and 58 airplanes. Prior to the late 1990s, Beech used a marginally effective, hollow, black rubber P-shaped seal system in their effort to seal these doors. It didn't take long before the shortcomings of that system became apparent.

The most common problem is in maintaining a good seal where the upper edges of the two doors meet. Beech relied on a soft rubber plug for a watertight seal where the hollow vertical seal is tangent to the matching horizontal seal bonded to the upper door jamb. Even when new, this design was, shall we say, a pretty optimistic solution for the inherent problems in this location. A little misalignment, coupled with the natural hardening of seal material that occurs with time, and a water leak in this area is inevitable.

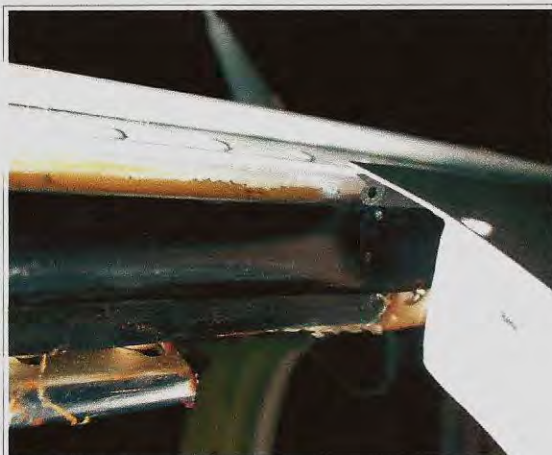
Secondary P-seal installation on door.

Here at Air Mod, we buy a hollow P-shaped soft rubber seal from Home Depot (I jokingly call this the Aircraft Supply department), sold under the MD brand, which we bond to the vertical and upper edges of the cargo doors. The photo shows

the orientation and approximate position of the P-seal. We're careful to locate this seal so that it facilitates a thorough closure against the original seal, paying very close attention to the upper corners and where the two cargo doors meet. After the new secondary seal is installed, close the door and insert a business card between the two seals. You should feel some resistance, indicating a snug fit. The final leak test is done with a garden hose. Be prepared to try this more than once. The Home Depot seals are inexpensive, so a second or third try is painless enough.

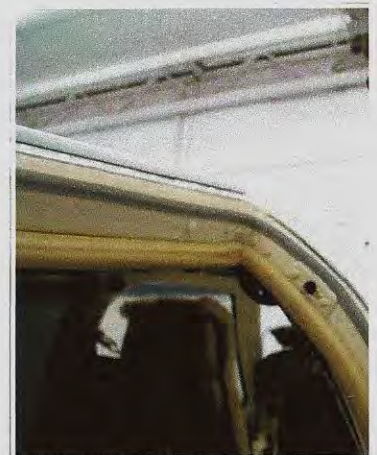
New Beech silicon rubber seal system.

If your original seals are beyond help, here's the real fix. The #36-4015-1 kit is a durable and effective solution for leaky cargo doors. The kit places a seal on both the door itself and the door jamb. It comes with all components; adhesive; and well-written, illustrated installation instructions. The current cost of the kit is about \$750. Installation time, including the necessary repainting of doors and jamb, is approximately eight hours. Doors and jambs will often

The results speak for themselves: A door seal that looks good, works well, lasts a long time due to its being silicon, and has a clever little silicon flap that seals the formerly troublesome gap where the cargo doors meet. I love it!

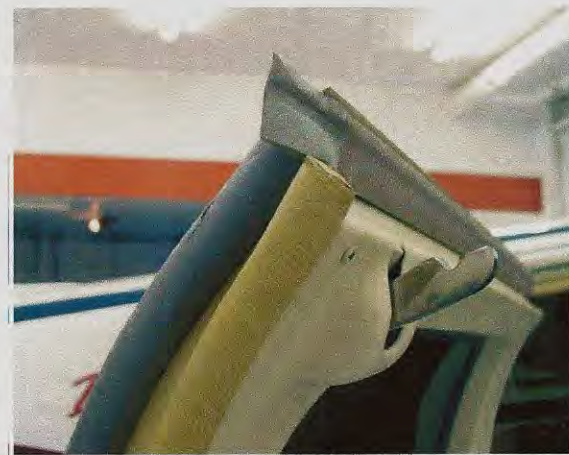
The little rubber flap that works.

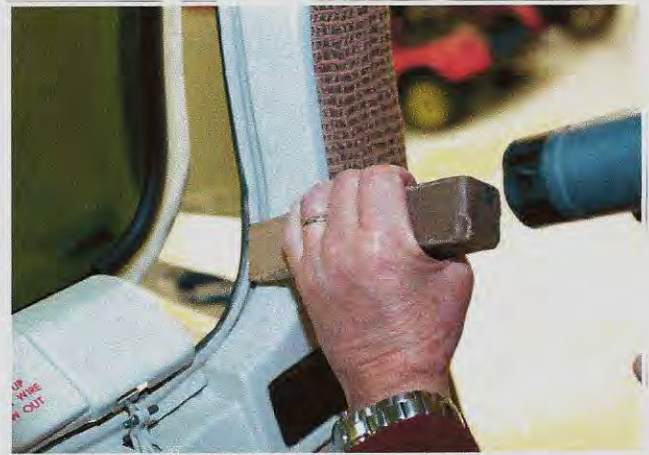
Leather-tipped wood drift and hammer re-forming the flange of the opening window.

So let's get down to the last sealing issue – center opening windows. During a tour of the Beech factory in 1973, I observed something I wouldn't have expected to see. A worker was using a hammer and a piece of wood to adjust the contour of the metal flange that holds the rubber seal for the opening windows. Re-forming these flanges is truly the best way to establish a good fit between the opening window and the airframe after new seals are installed. Be sure to open the window before employing the hammer technique, or a cracked window may be the result. This adjustment is often necessary after new center windows are installed.

Beech changed the design of this flange in the late '70s to accommodate a larger diameter seal, improving our ability to seal these opening windows. It may still be necessary to re-contour even these later style
