# Side Panels

By Dennis Wolter

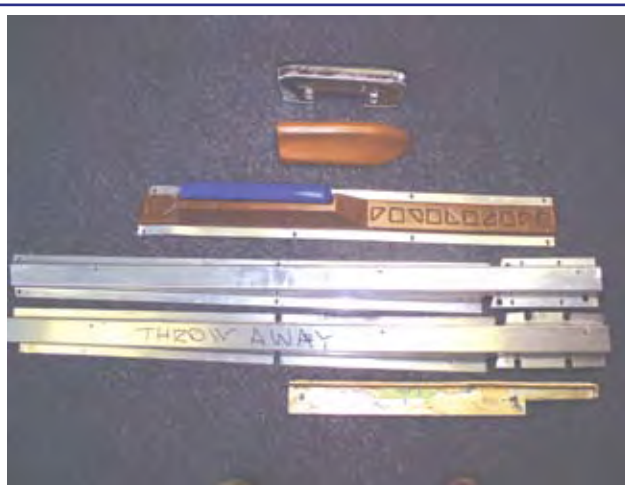
***From top to bottom: 60's injection molded, 70's rubber molded, late 70's-80's composite, and 70's 210 all aluminum (three pieces - center one is discarded).***

In the entire Cessna line of piston airplanes, the armrest designs fall into five categories, based on materials and method of construction and upholstery. Group One: From 1947 through the late 50's, Cessna fabricated the armrests in 172s, 182s, and twins using built-up aluminum components. Group Two: Plastic armrests came into the game in the early 60's in the form of fairly durable injection molded plastic armrest bases with a separate metal-backed screw-mounted pad; these were installed on 172s, 182s, 206s and a few 210s. Group Three: During the 1970's Cessna switched to a rubber molded, metal reinforced, painted type of (not-so-great) armrest for most of the single engine line. Group Four: Not to be outdone on the bad design scale, Cessna created a, shall we say, more challenging armrest design. From the late 70's through 1986, 172s, 182s, and 206s were built with composite armrests. These beauties were basically a vacuum-formed plastic shell with minimal aluminum reinforcement

mounted pad; these were installed on 172s, 182s, 206s and a few 210s. Group Three: During the 1970's Cessna switched to a rubber molded, metal reinforced, painted type of (not-so-great) armrest for most of the single engine line. Group Four: Not to be outdone on the bad design scale, Cessna created a, shall we say, more challenging armrest design. From the late 70's through 1986, 172s, 182s, and 206s were built with composite armrests. These beauties were basically a vacuum-formed plastic shell with minimal aluminum reinforcement

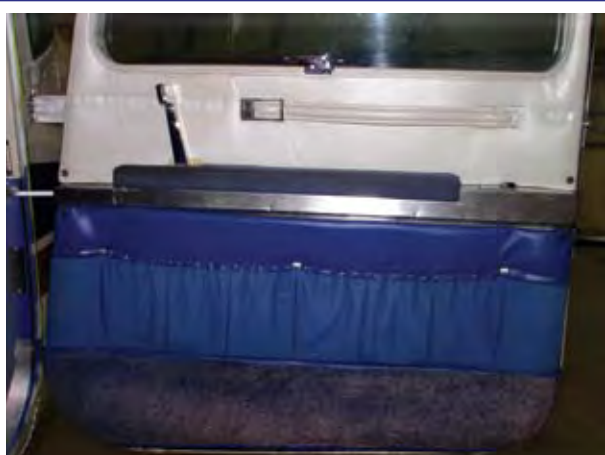
***Original factory finish, all aluminum 210 armrest.***

In view of the fact that the late 40's and early 50's armrests in Group One were so well made, I really have no repair information to pass on, with one exception. The later 210 all-aluminum armrest systems, like the earliest 172-182 components, are padded and upholstered with traditional methods, but one 210 detail is worth mentioning. Cessna originally installed a sort of buffed full-length aluminum overlay panel and black rubber end plugs to

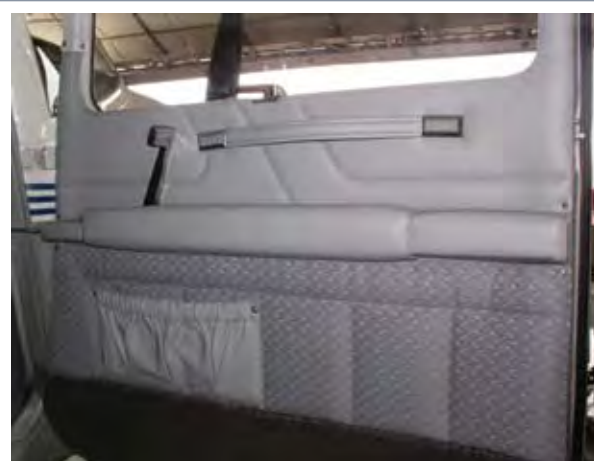
***The same armrest with the dented aluminum overlay removed, and the entire assembly covered in leather.***

trim out the aluminum armrest substructure. Here at Air Mod we send the usually dented and scuffed soft overlays to the landfill, and upholster the base structure with nice top-stitched ends to cover the unsightly black plugs. Looks great, and is quite durable.

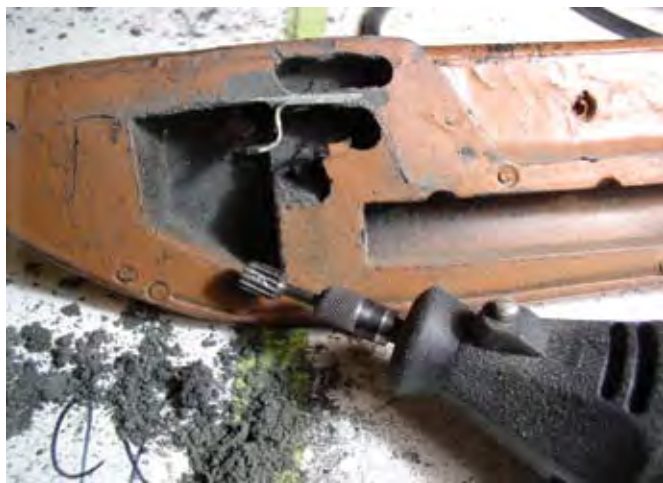
*The old foam is easily removed with a router bit and a moto tool.*

Start the repair by mining out all the old urethane foam and thoroughly clean any foam residue in the area that needs repair. On the finished side it's important to sand through the wood grain decorative finish. All this cleaning is necessary to ensure optimum bonding of the repair adhesives. What we have found to work best is a super thin cyanoacrylate adhesive, insta-set spray accelerator, and hobbico 2 oz. fiberglass cloth from Lone Star Models (972-218-9663). The first step is to allow capillary action to draw the thin adhesive into the cracks and then instantly cure the adhesive with the insta-set

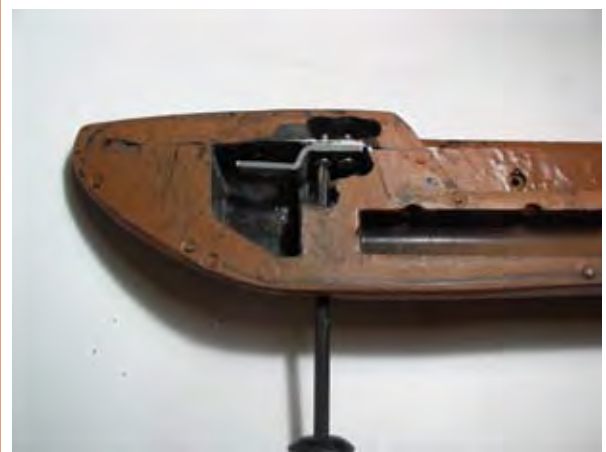
*The new steel tab being installed with machine screws and nuts. Note the access holes that we drilled through the rubber base to facilitate installation of the mounting screws.*

and every fastening known to man has been employed in an attempt to re-secure the armrest. The fix is to fabricate a more durable heavy-duty mounting tab that is secured to the original mounting tab structure using 4-40 steel machine screws and nuts. You gain access to this area by removing the surrounding foam rubber with a router bit on a Dremel rotary tool. Don't forget to open the slot on the door bracket to accommodate the thicker steel mounting tab. I have included a shop sketch of a 1/8" thick steel tab we think works quite well. Strong, durable and easier to remove and install – all good stuff!

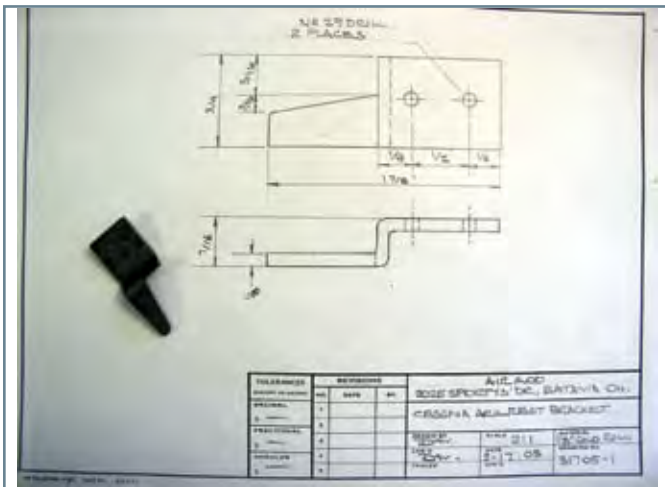
*An engineering drawing of the 1/8" steel mounting tab.*

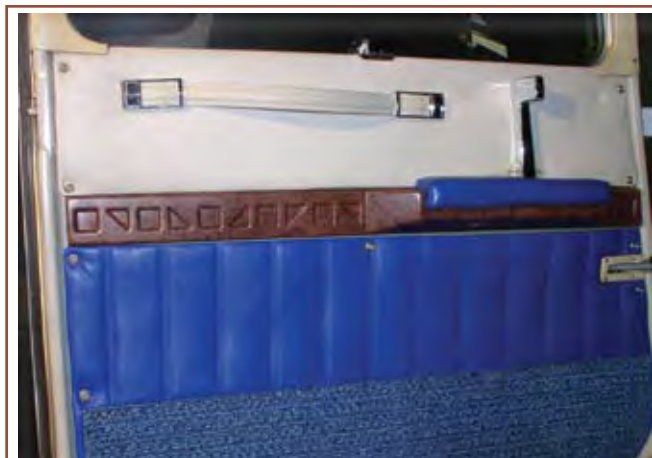
*Original factory finish-out for the 80's composite armrest.*

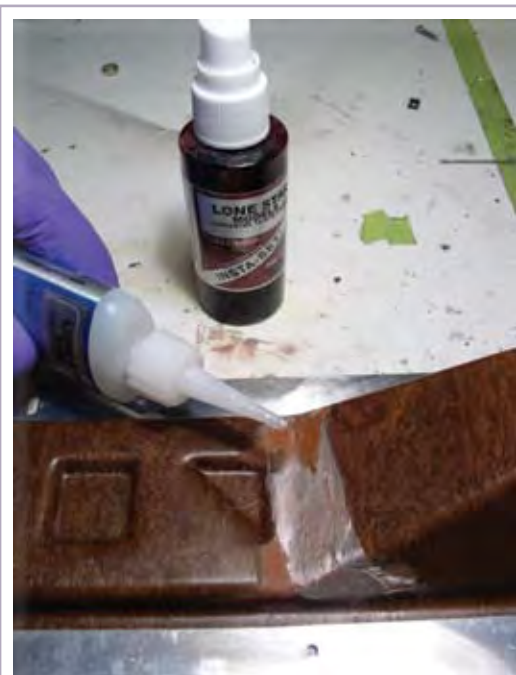
*Cyanoacrylate adhesive is being applied to the fiberglass-reinforced crack area.*

accelerator. You will notice that a great deal of heat is generated as the curing process occurs. This heat helps to thoroughly bond the plastic so you end up with a strong thermal and adhesive bond. The next step is to reinforce the repair. This is done by cutting the 2 oz. fiberglass cloth into whatever shape will properly contour to the location of the repair. Bond the reinforcing cloth to the surface with the insta-cure adhesive. In high stress areas we will bond two or sometimes

three layers of cloth to both sides of the repair. Increase the size of the fiberglass cloth with each layer so as to eliminate having a pronounced relief of all three thicknesses of cloth ending at one edge of the repair. The final plastic repair step is to smooth out the surface by sanding the area with 150 grit sandpaper, and for an extra measure of strength, reapply a thin coat of post-sanding adhesive and catalyst. A safety note: use gloves, a charcoal painter's mask, eye protection and lots of ventilation as these chemicals contain some unhealthy stuff.

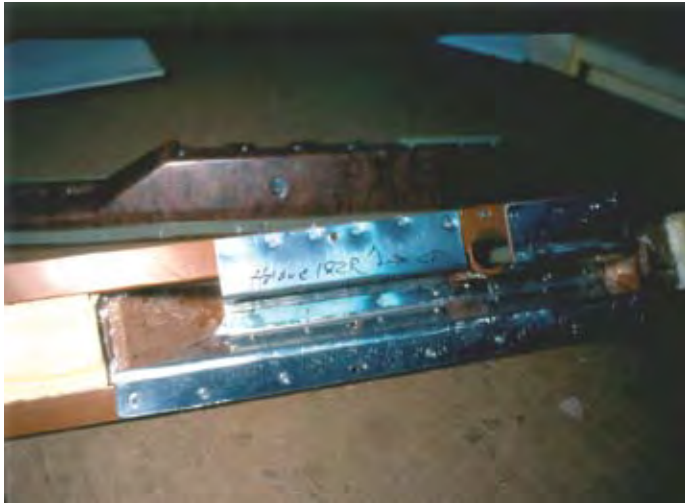
*Typical riveted aluminum reinforcement - very strong!*

Now it's time to reinforce the armrest with aluminum so that it doesn't fail in the future. It's all about making it "better than new." Using .032" 2024 T3 aluminum, fabricate a formed metal backing piece that reinforces both the armrest and its mounting points. In most installations we secure these aluminum shapes to the plastic armrest with click fast 1/8" hardware store pop rivets. Always install the rivet with the big factory head on the plastic side and the field head (the one that forms when you pop the rivet) on the aluminum side. We like to fabricate a .040"-.050" aluminum armrest bracket

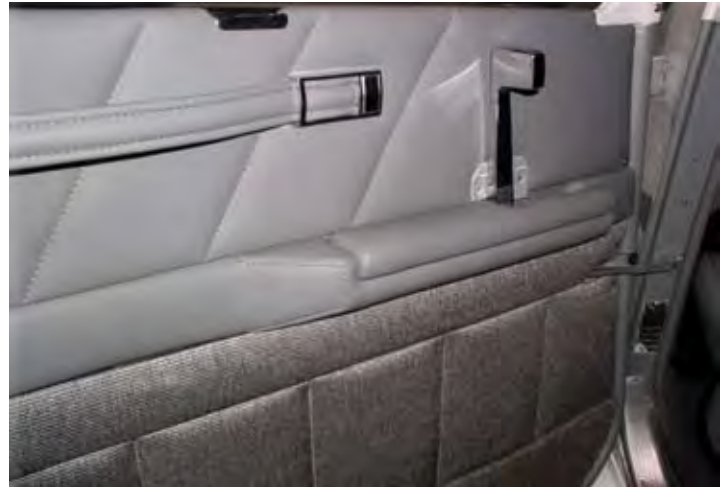
*Composite armrest assembly, padded and upholstered. Looks great and is very durable.*

We have found the best way to cosmetically finish these plastic based armrests is to cover them with vinyl or leather. Even though the plastic can be prepped and painted, upholstery is definitely better looking and more durable.

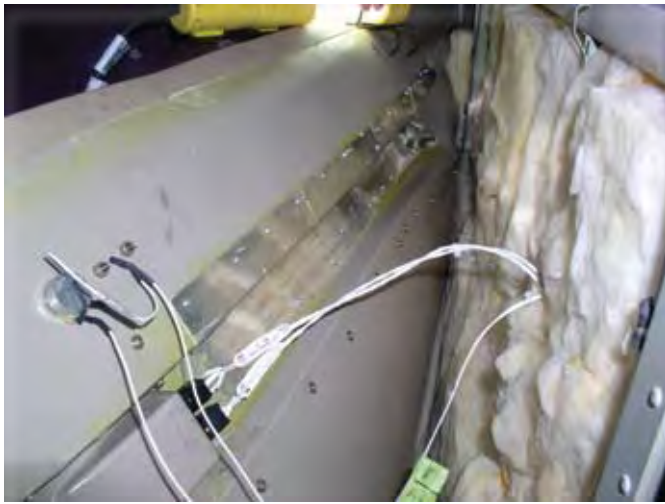
*Aluminum reinforcement on a vacuum formed armrest (this component had cracked after only 100 hours in service).*

that is mounted to the airframe. This hard-mounted bracket will ensure that there is enough structural integrity in the armrest / mounting bracket system to handle the loads imparted by even the heaviest of passengers.

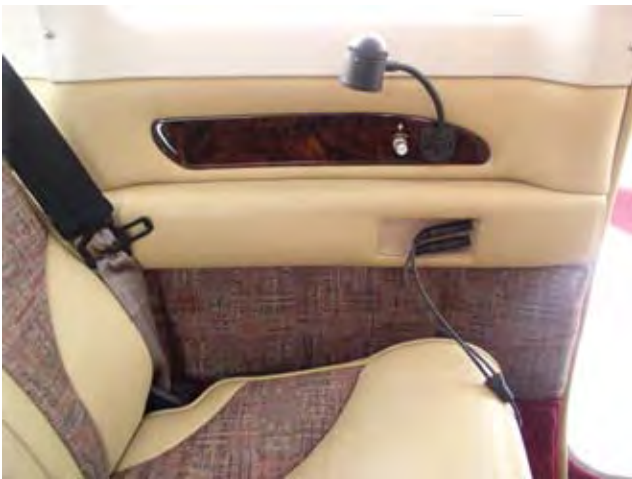
*A new 206 done in our shop, with reinforced and upholstered side panels*

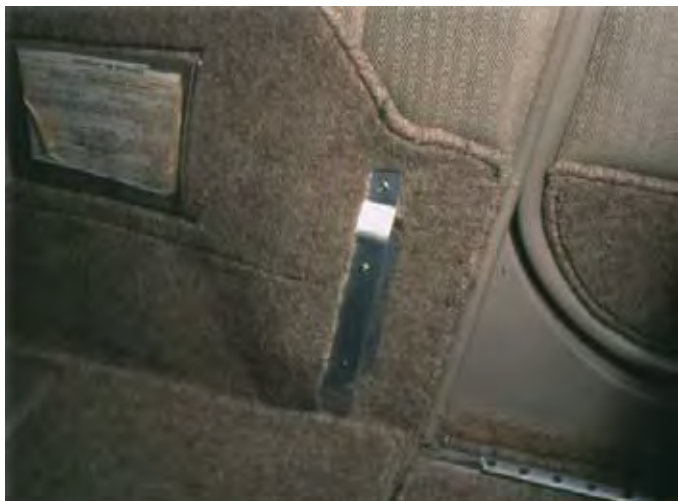
*Re-designed and relocated heat outlet*

reinstalling the front seats requires jamming the seat frames hard against these delicate outlets. The fix is to move the outlets 2" forward, and fabricate a new outlet piece using formed .050" aluminum extrusion. We like to attach this new, sturdier outlet with two 1½" long screws that push against a .040" aluminum backing plate. This technique ensures that the outlet remains fully open, helping to eliminate a cold cabin during winter. Looks better, works better, isn't easily damaged, and easy to assemble and disassemble – enough said!

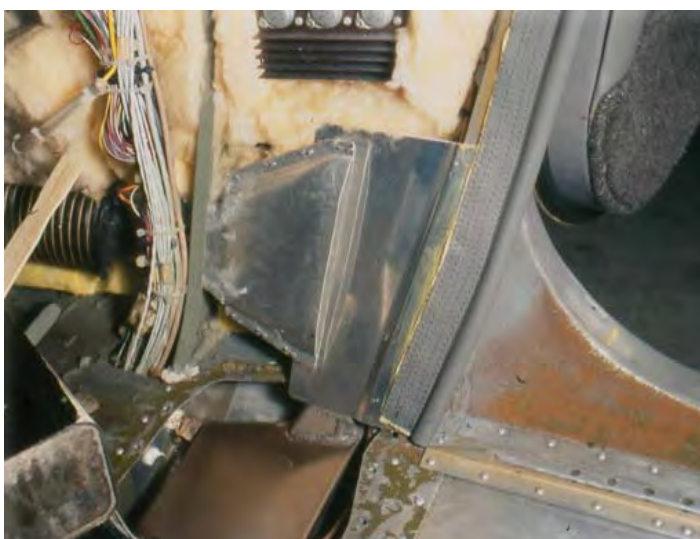
Two very consistent problems exist in this area. One is the fact that Cessna installed a very flimsy stamped aluminum heat outlet too close to the edge of the door. Just removing and

*Heat outlet, re-trimmed and mounted 2" forward of its original location*

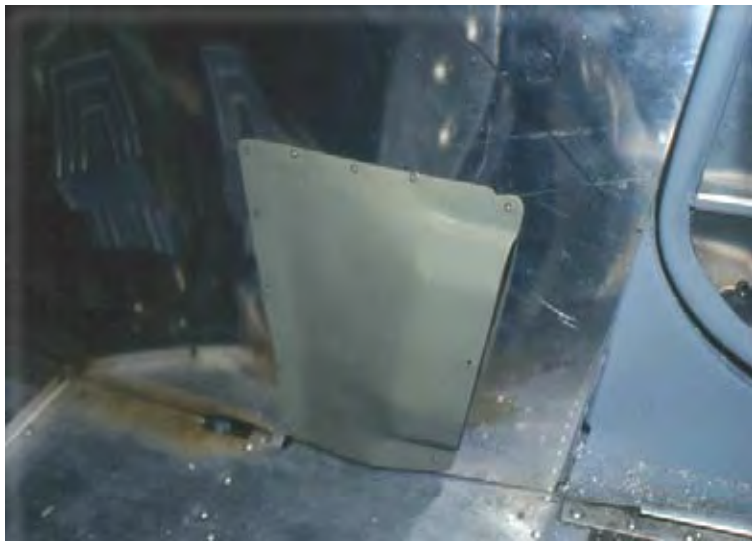
*New .025" aluminum side panel with the re-located original heat outlet cover riveted in place.*

It's time to start repairing any side panel components we've decided not to replace. The photo pretty much shows the problem. The condition of the 182 side panels shown here is pretty representative of the now 30-year-old interiors we see in our hangar. Between the metal work required to relocate the heat outlet, and numerous tears and dents as in the example shown, we most often end up replacing the forward side / kick panels on most Cessnas. Since this panel has to come in and out of the airplane frequently, we will fabricate it from slightly thicker .025" 2024 T3 aluminum in an effort to make it more durable.

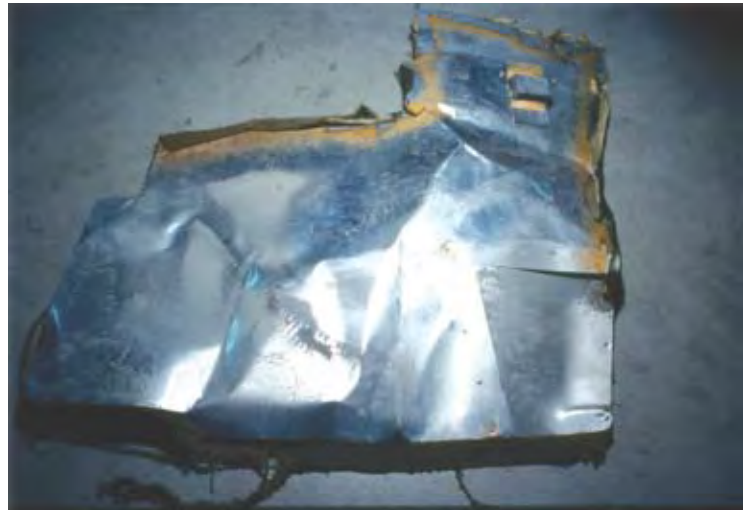
*Original forward side panel removed from a 182. The condition we see here is typical.*

For the aluminum side panels that we intend to reuse, the repair techniques are straightforward. After we strip off the old cover and backing materials, we grab a small ball-peen hammer and lightly begin tapping out the dents and creases in the thin aluminum. Working on a hard, flat surface is as important as employing proper hammering techniques. Using the rounded side of the hammer, lightly tap

the damaged area. Start at the outer portion of the deformation and work inward toward the apex of the dent. Don't pound the apex of the crease down first. Heavy blows with a flat hammer will stretch the metal, making it quite wavy. Practice makes perfect. Use a piece of side panel that you don't intend to reuse to get the hang of dent removal. It's all about not stretching the metal.

Rips and tears in the metal can be repaired using overlay patches held in place with 1/8" hardware store rivets. We like to tap the soft pulled rivets a little flatter and then disc sand both the factory and the pulled head to reduce the thickness of the heads. This makes for a smooth, unseen repair once the panel is padded and upholstered. Again, try this stuff on a junk panel first.
