Corrosion

By Dennis Wolter

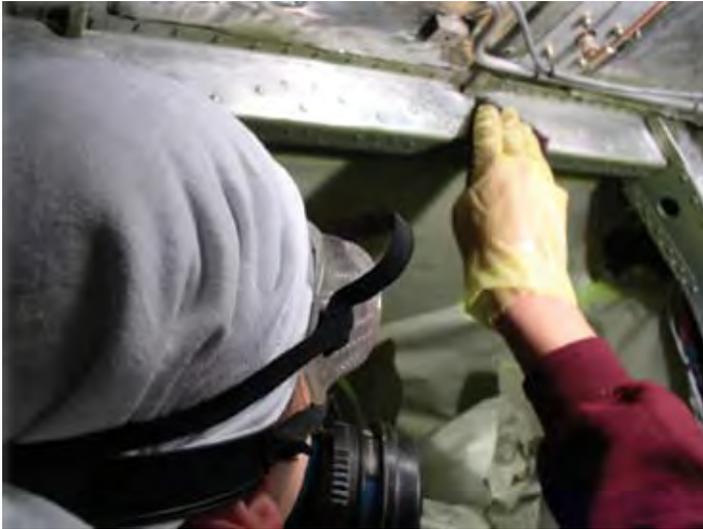
Head cover, eye protection, charcoal mask, long-sleeved shirt, gloves, scotchbright, lacquer thinner and lots of tenacity - not much fun!

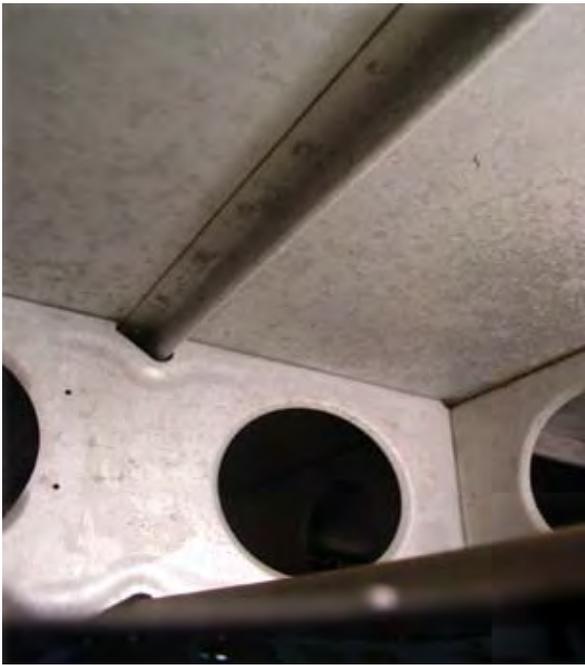
Moderate surface corrosion - a thin powder-like crust with very slight pitting in the metal.

The second stage is the presence of visible aluminum oxide in the form of a gray powder or crust on the surface of the metal, or under the surface of the

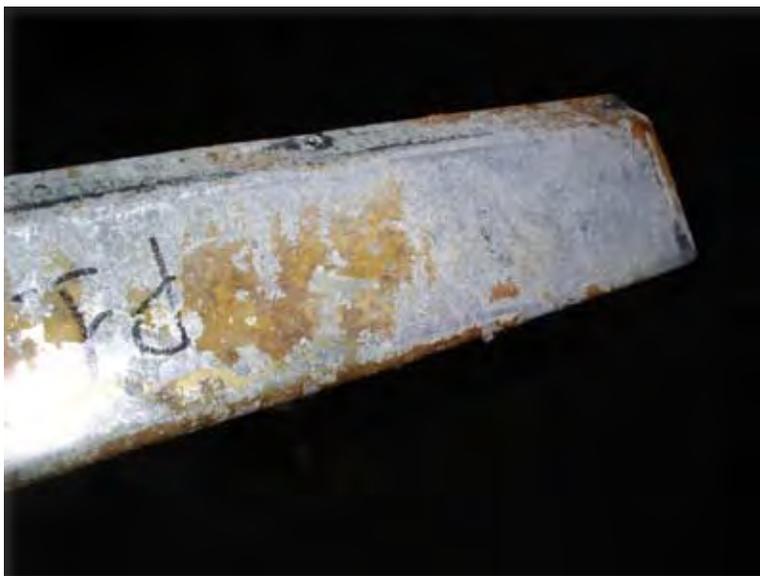
Severe surface corrosion - very crusty with deep pitting; note glue residue on the metal.

the picture is worth a thousand words. The only good news is that when the corrosion between the damper pad and the skin is this bad, the pad is easy to remove. This is a common situation, especially in airplanes that are stored in a humid environment.

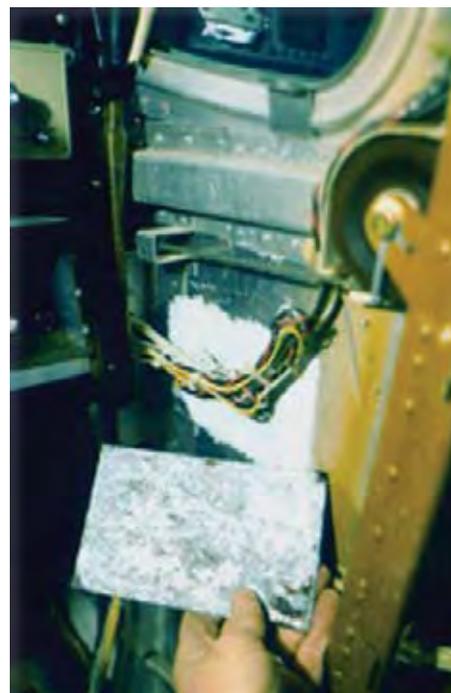
Heavy surface corrosion found under a lead vinyl sound damping panel.

of production in 1986 had lead vinyl skin-stabilizing dampener panels bonded to the inside surfaces of the bare aluminum skins. Even worse, Cessna used hydrosopic glue that soaked up and retained moisture. How perfect – all the bad stuff in one place (dissimilar metal and permanent moisture). Again,

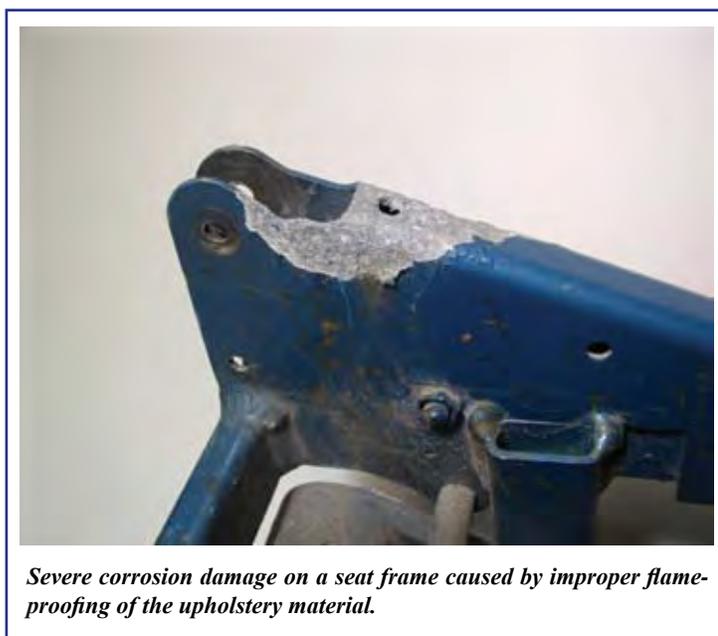
Severe corrosion damage on a seat frame caused by improper flame-proofing of the upholstery material.

Surface corrosion isn't limited to the airframe. Over the years, we have seen several severely corroded seat structures caused by the improper flame proofing of upholstery materials. The flame proofing chemical that is applied to finish materials contains a bromide salt. If it is improperly applied or applied in too great a concentration, this salt, if exposed to high humidity or water, will mix with the moisture and create an electrolytic vapor or water solution that causes severe corrosion in aluminum or steel. The seat frame shown here was so severely corroded by this phenomenon that it had to be replaced.

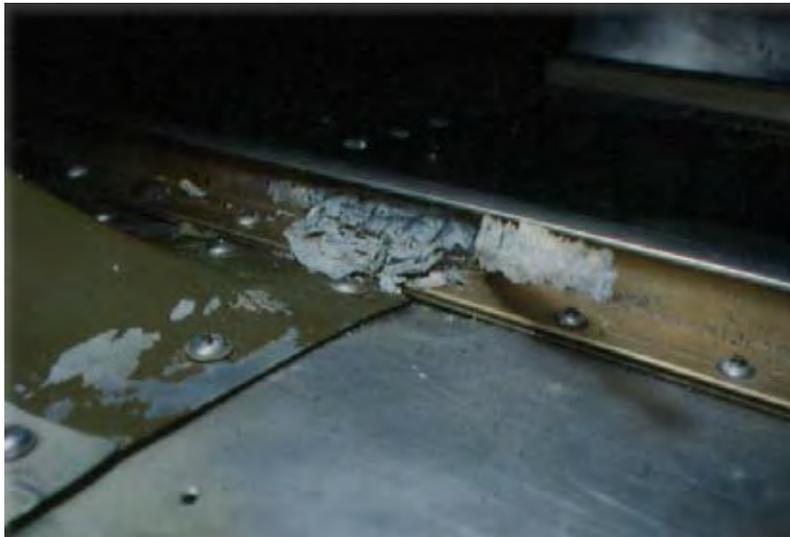
Cardinal seat rail split open by inner granular corrosion (this airplane had come out of an annual one week prior to being delivered to our shop for an interior).

ferential metal content of the alloy or a contaminant that became imbedded in the alloy during the manufacturing process. These dissimilar materials cause a very high level of inner electron flow (galvanic action) in the metal, resulting in the formation of internal corrosion and oxidation, and eventually making the metal swell as the pressure from the inner granular corrosion oxides try to push the molecules apart. At a very advanced stage the metal begins to crack and split open, revealing the presence of powdery gray oxide.
