# Renovating an Interior

## Part Four:

### Understanding Corrosion

DENNIS WOLTER continues his series of articles about interior renovation with a deep dive into how corrosion occurs, as well as where you're most likely to find it.

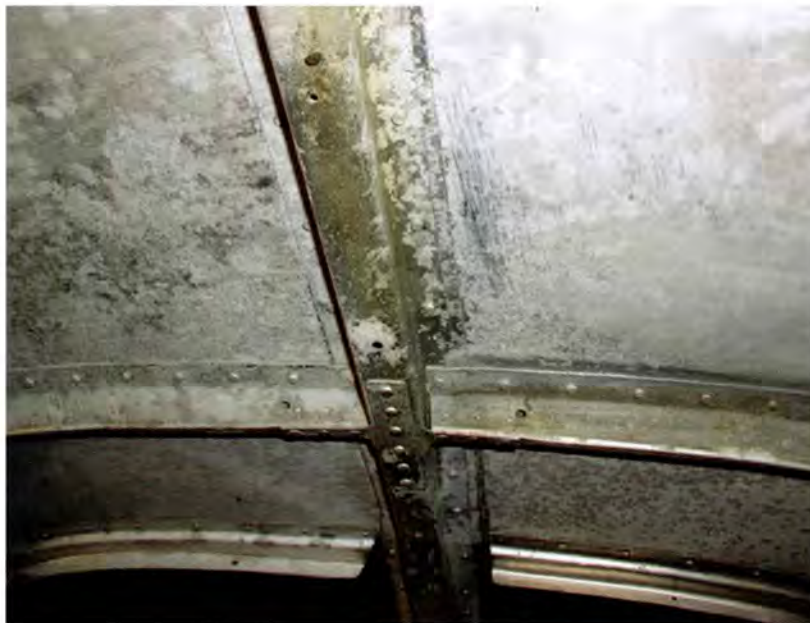
*Surface corrosion on an upper cabin skin.*

Knowing that Cessnas are prone to corrosion in the upper areas of the cabin, I unzipped the spanwise headliner access, pulled down the original fiberglass insulation and found a mess. The top photo on Page 25 says it all. On a scale of 1 to 5, I would rate this level of corrosion an unhealthy 4+. I'll detail the cleanup and treatment of this particular airplane in a future article.

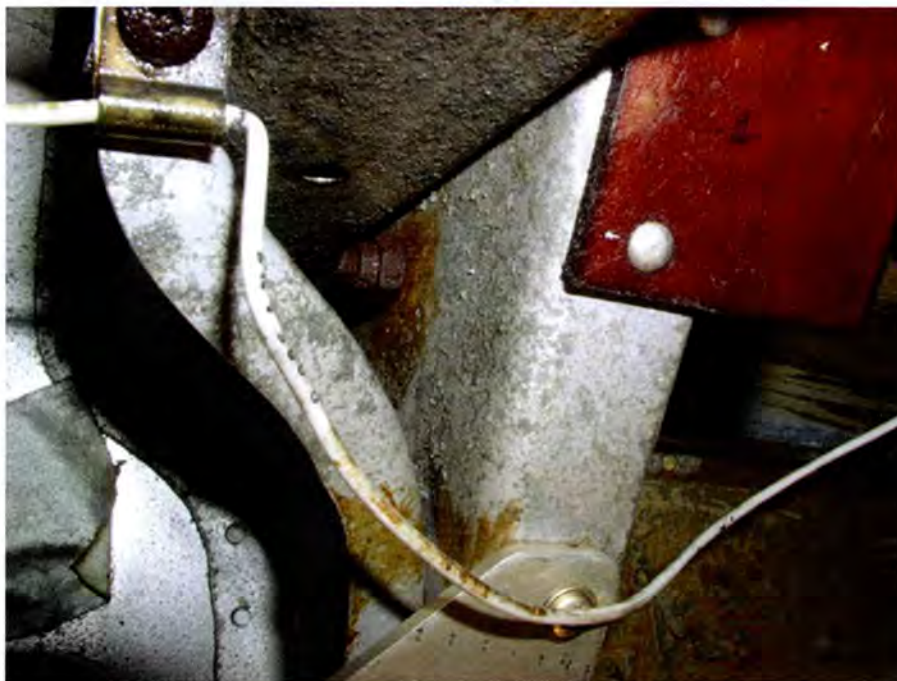
*Severely corroded aft wing spar attach point in an airplane represented to the buyer as being almost corrosion-free.*

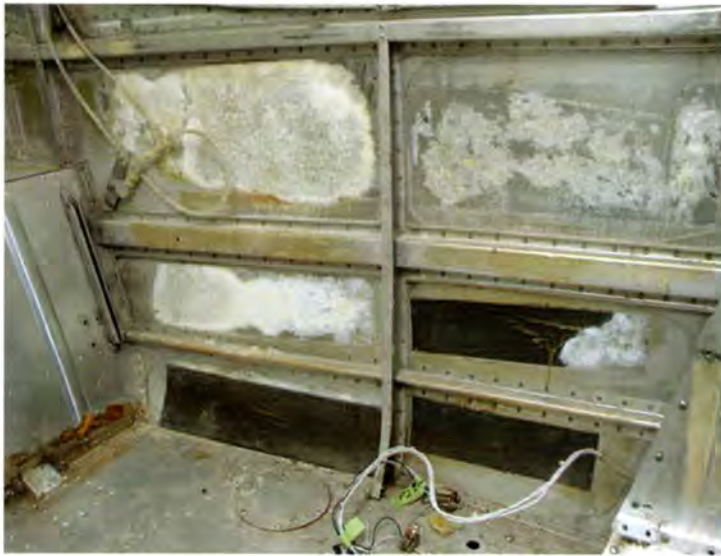
*Corrosion caused by galvanic action under glued-in-place lead vinyl skin damping panels.*

To make things worse, Cessnas manufactured from the early 1970s through 1986 had lead vinyl skin-stabilizing damping panels. The panels were bonded

to the inside surfaces of the bare aluminum skins. Even worse, Cessna used a hydroscopic glue that soaked up and retained moisture. How perfect—all the bad stuff in one place (dissimilar metals and permanent moisture).

Again, the picture is worth a thousand words. (See photo on Page 26, top.) The only good news is that when the corrosion between the damper pad and the skin is as bad as shown in the photo, the pad is easy to remove. This is a common situation, especially in airplanes that are stored in a humid environment.

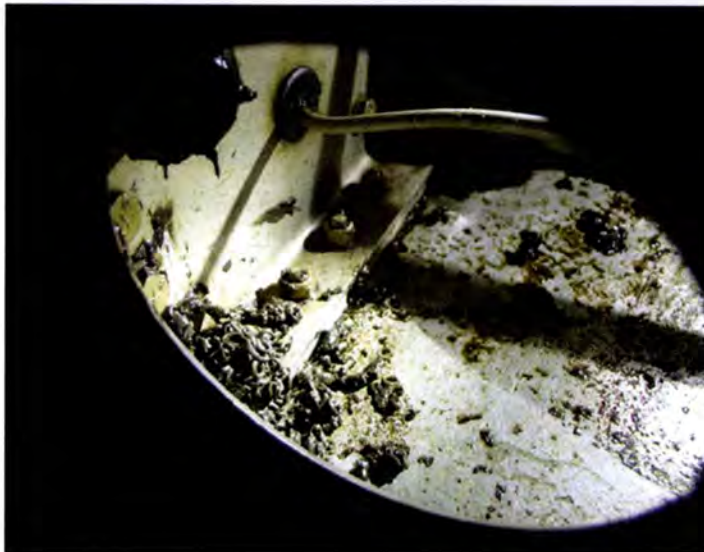
*Extensive corrosion on belly skin caused by dirt.*

The second culprit in the corrosion game is dirt. Exhaust residue, oil residue, industrial pollutants, salt air and certain adhesives can all build up over time. Left uncleaned, these destructive contaminants set the stage for corrosion issues. A clean airplane is a happy airplane.

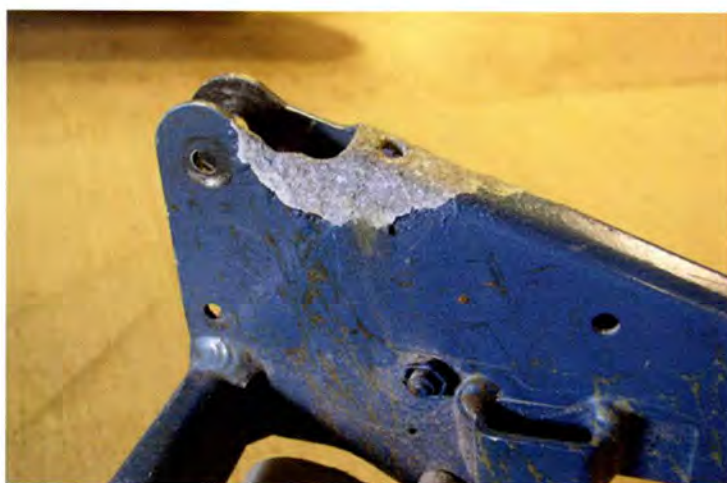
*Serious seat corrosion caused by improperly flameproofed upholstery material coming into contact with an aluminum seat frame.*

Surface corrosion isn't limited to the airframe. Over the years, we have seen several severely corroded seats and airframe structures caused by improper flameproofing of upholstery materials.

If the bromide salt chemical that is applied to finish materials during flame treating is exposed to water or high humidity, it will create an electrolytic vapor or water solution that causes severe corrosion in aluminum or steel. The seat frame shown here was so severely corroded by this phenomenon that it had to be replaced. (See photo on Page 28, center.)

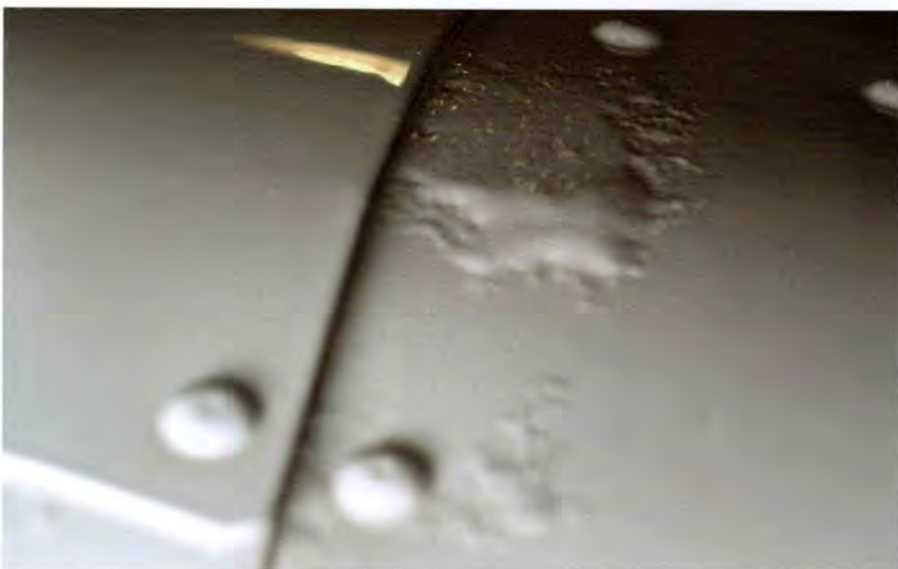
*Filiform corrosion creeping out under the paint of an improperly cleaned lap joint. The joint should have been more carefully cleaned prior to applying primer and finish paint.*

This is corrosion that develops underneath a coating such as paint. Filiform corrosion is generally caused by contaminants that were left on the surface or trapped between two mating surfaces before the primer and paint were applied.

Once trapped by the paint, the corrosion develops under the paint and has the appearance of a spidery growth or a lakebed pattern. (See photo on Page 28, bottom.)
