# Renovating the ABS/ASF Bonanza

## Part 5: Window Frames

By Dennis and Cynthia Wolter, Air Mod

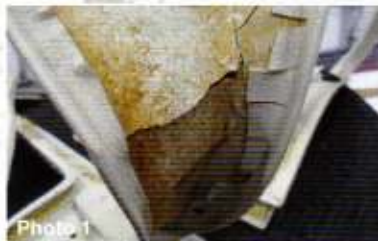
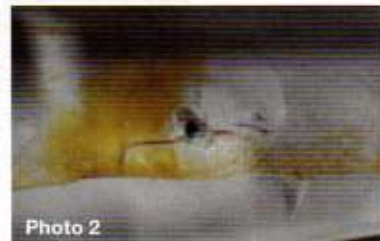
The second group involves **window frames that have been covered with vinyl or leather**. I do not believe it is a good idea to wrap plastic frames with any finish material. Leather shrinks as it ages and can cause cracking as it draws tightly around the compound shapes of this delicate plastic. Vinyl has chemistry in it that, when exposed to extreme temperatures, will "gas out" and accelerate degradation of the plastic. I have included a couple of pictures of what we often find under the covered window frames (**photos 1 & 2**). The only option here is to buy new frames.

For those window frames that have been covered with vinyl or leather, the usual fix is to replace the frames with new components and finish them with acrylic lacquer or SEM coating. The labor required to carefully remove the cover material and bonding adhesive from the original frame, and then repair what damage you will find hidden underneath, can easily exceed the cost of buying and installing new frames.

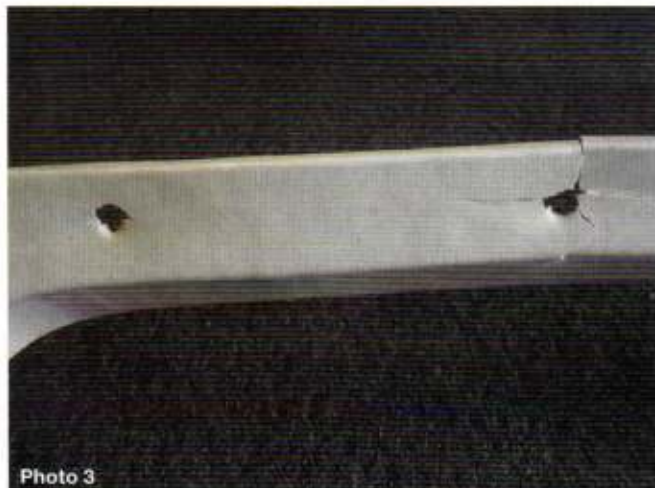
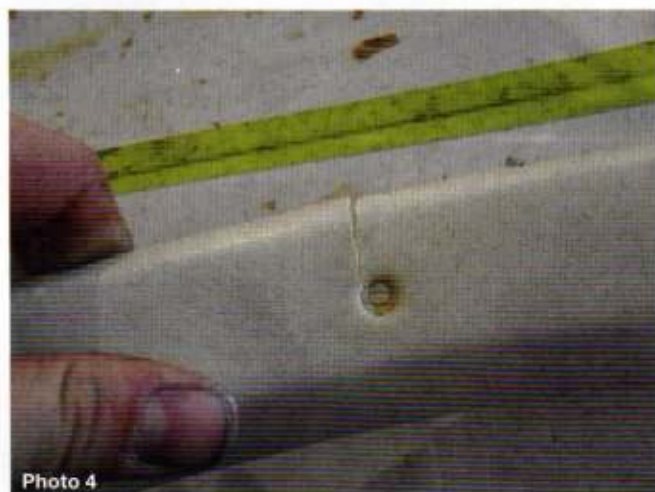
To present a comprehensive look at the problems and issues with these plastic window frames, included in this article are some repair processes that go beyond the work we did on the ABS/ASF Bonanza. The ASF A36's window frames fell into the first category: untouched since new, no covering, no paint, and no previous attempts at repair. However, due to the age of the aircraft and the fact that for the past seven or more years it had been stored outside, the frames contained a significant amount of damage. They were as brittle as eggshells, making them well beyond practical repair (photos 3 & 4). The

good news was that our shop has accumulated an almost complete set of repairable and flexible A36 window frames over the years that we contributed to the project (more on the repair of these components later). Plane Plastics also generously donated several new pieces to complete the set.

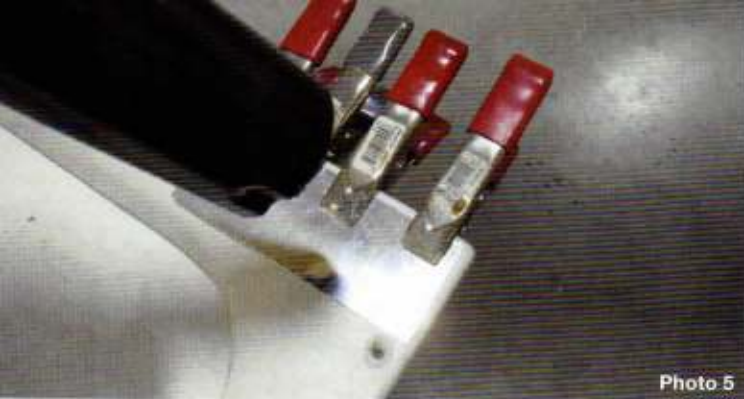
Photo 5

Heat and form the frames back to their designed shape using a 1500°F heat gun available at place like Harbor Freight (**photo 5**). Control the shape of the heated, soft plastic using aluminum or wood shapes and clamps.

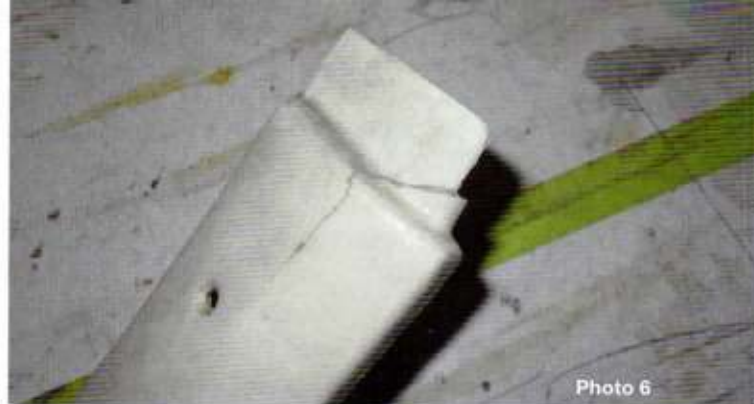
Photo 6

Apply two layers of two-ounce Hobbico fine-mesh fiberglass cloth (available from Amazon) and the Polyfix adhesive to the back surface of the area being repaired and one layer on the

front surface. This fiberglass reinforcement will ensure a stable and strong repair (**photo 6**).

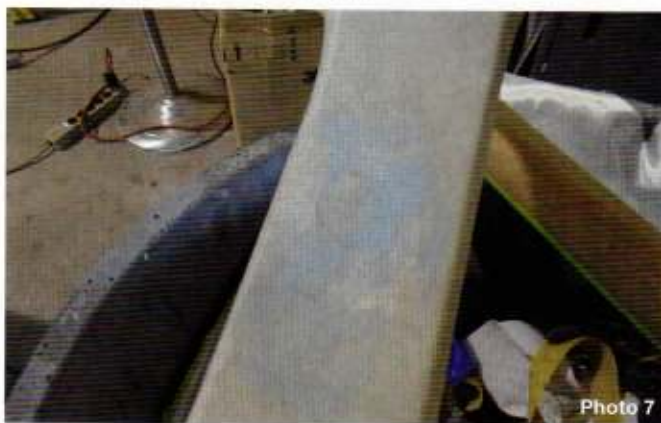
Photo 7

The final step is to apply a thin layer of automotive body filler and high-build, sandable primer to the finish side of the window frame. These items can be found at your local auto body or paint supply store. A little sanding and the application of final finish coats of acrylic lacquer will produce an invisible, strong, and durable repair (**photo 7**). Use either acrylic lacquer, available from auto paint supply stores, or SEM spray paint from Plane Plastics.

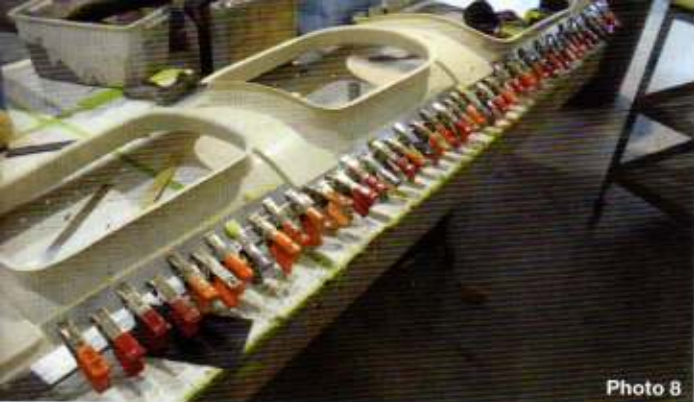
Photo 8

bonding 0.040" formed aluminum anywhere that has deformed in the past, as it will likely deform again in the future. One such area is the upper edges of the window frames where they meet the headliner. We bend a 3/16" lip along the edge of a two- or three-inch-wide piece of 0.040" aluminum. We sand both bonding surfaces with 80 grit sandpaper, then apply a generous coat of contact cement and allow it to tack up for 10 to 15 minutes. Be certain sure to use high-quality, brushable contact cement – we use MC5 brushable, sprayable contact cement that we purchase locally at Miami Corporation in Cincinnati. Do not use 3M 1300L weather strip adhesive; it will discolor the plastic and does not have the same bonding qualities as contact cement. Once the adhesive has cured, we clamp the formed aluminum reinforcements in place with spring clamps (**photo 8**), using paint sticks on the front side to protect the textured finish of

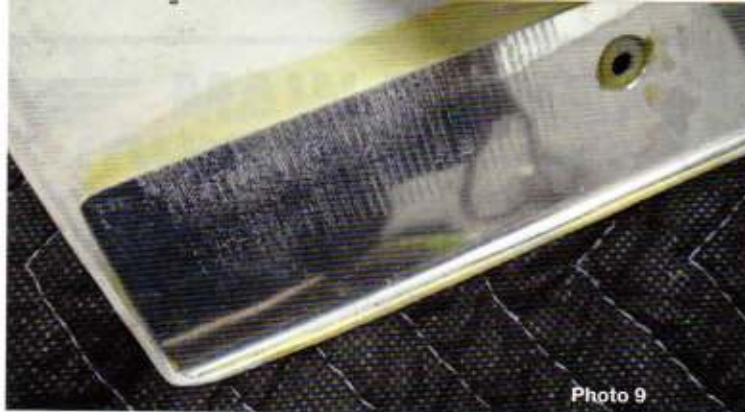
Photo 9

the plastic. We heat the aluminum with a heat gun until it's hot to the touch, then allow the bonded area to thoroughly cool. After the clamps and paint sticks are removed, we have a thermally stable, very straight edge that will not deform in the future (**photo 9**).
