INTERIOR RENOVATIONS - ARMRESTS

by Dennis Wolter, Founder & Owner - Air Mod, Inc.

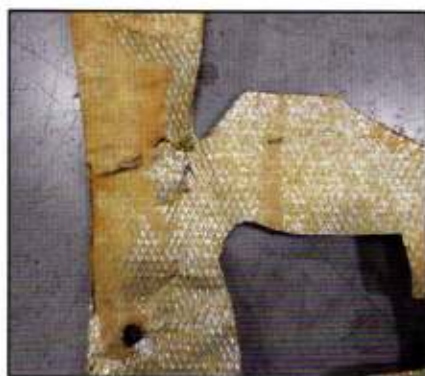
In later interiors, Cessna stuck with very thin .016" aluminum side panel backing material. However, in an effort to make it more rigid and durable, they developed a process of putting an embossed quilting pattern on this material. Over time, this quilting produced no improvement in the durability of the side panels. The only fix is to fabricate new side panels using more rigid aluminum, either .020" or .025" 2024T-3 tempered structural aircraft aluminum.

The quilting process applied to .016" aluminum didn't solve the delicate nature of original factory side panels.

Fabricating side panels using this more durable material greatly reduces the potential for damage during removal and reinstallation.

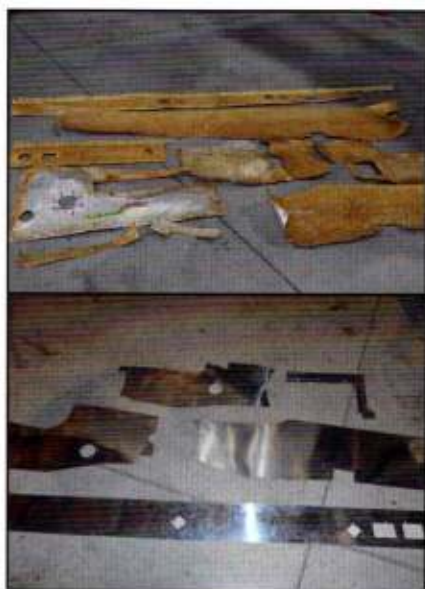
Top: Unusable set of 310R original factory side panels.

Bottom: A new set of 310R side panels, fabricated using more durable .020" or .025" aircraft aluminum.

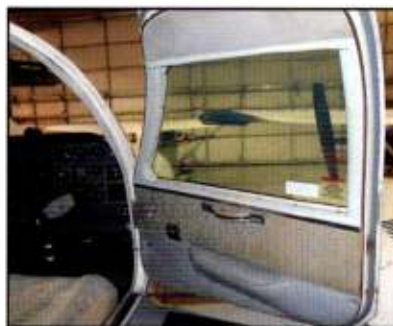
The formed stainless steel edge molding strips installed by the factory in an effort to create a pleasant looking edge closure. This tedious installation process makes it almost impossible to remove and reinstall the thin upholstery panels without damaging the panels, the stainless edge trim, or both.

Due to the flimsiness of the thin quilted panels, Cessna installed formed stainless steel edge trim pieces in an attempt to neatly hold these thin side panels in place. This made it very difficult to remove and reinstall the panels, and resulted in torn, deformed and ill-fitting side panels and stainless steel edge trim. Side panels fabricated with more rigid .020" or .025" aluminum do not require the complex installation of trim strips to create a nice looking and durable finished edge around doors and windows. And, as we said, these new panels are far easier to remove and reinstall.

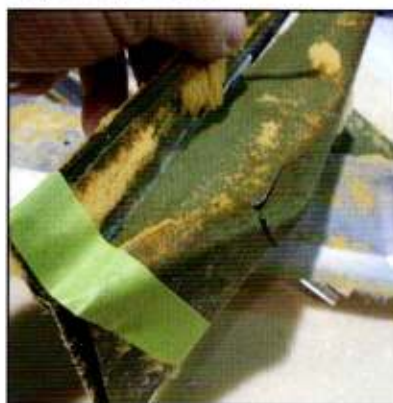
Typical damage found on plastic armrests on later-production wing mounted twin engine airplanes.

Let's take a look at the flimsy armrests that were installed in all 310s through 425s. These cabin length armrests have an aluminum base with plastic armrests riveted to them. That's right, plastic, the same stuff the delicate window frames are made of. The photo illustrates the condition we usually see when we remove the cover material from the armrests. The fix is to fabricate new armrests using .025" aircraft aluminum. With new armrests made, it's time to improve the flimsy way Cessna secured them to the sides of the cabin.

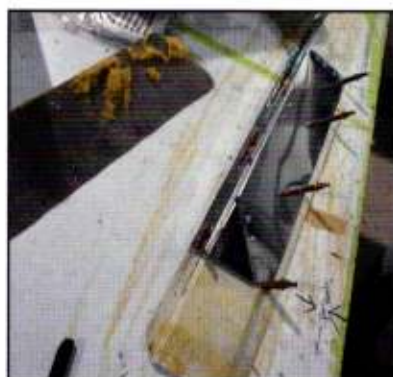
A new sturdy aluminum armrest being riveted to the original armrest base.

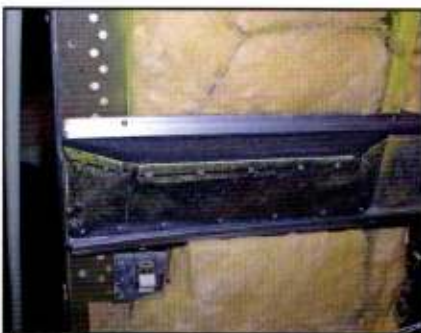
A rebuilt armrest assembly secured to the cabin side structure with sturdy extruded aluminum.

The fix is to rivet strong full length extruded aluminum rails to both the top and bottom edges of the repaired and upholstered armrests. We then thoroughly secure the renovated armrest to the cabin side structure with screws. This system of extruded aluminum rails creates an aesthetically pleasing mounting rail that allows for the installation of more durable side panels without needing unsightly screws to hold the new panels in place. The new panels fit neatly into the open channels of the extruded aluminum mounting rails creating a well-fitting, easy to install and remove side panel design typically found in corporate jet interiors.

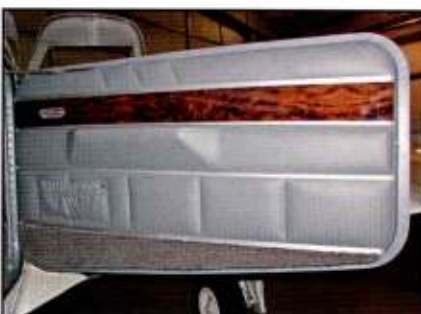
A finished door panel with hardwood inlay, rebuilt armrest and new .025" aircraft aluminum side panels, all securely held in place with nice-looking extruded aluminum divider rails.

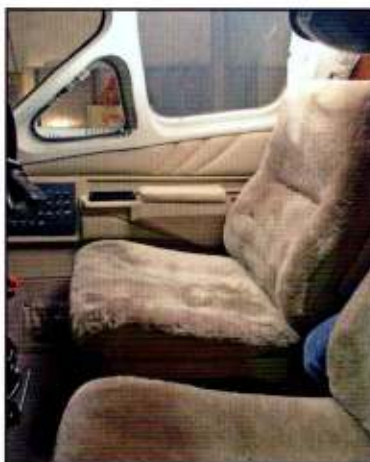
Moving forward to the often damaged, molded plastic armrest/side panel assemblies we find in the flight deck, we're faced with repairing any cracks and reinforcing the armrests with .040" aluminum. If the plastic side panels are badly damaged or they are brittle due to exposure to the sun, new molded plastic panels are

New, reinforced, aftermarket flight deck side panel armrest.

available from Plane Plastics. These aftermarket components are molded using a superior, thicker, and more sun tolerant Lustran brand of flame retardant polymer. To ensure long life, we still reinforce the new panels with .040" aluminum and finish them with three coats of color-matched ultraviolet reflective lacquer-based paint.
