INTERIOR RENOVATIONS - PART FOUR

by Dennis Wolter, Founder and Owner, Air Mod, Inc.

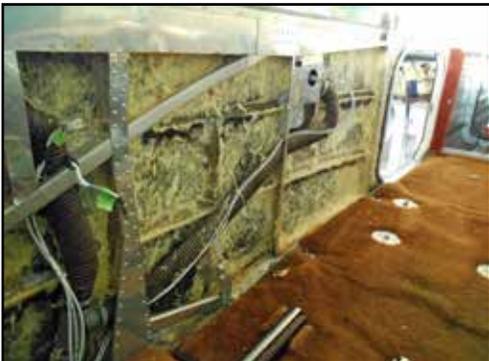
Tar-covered cabin skins and structure.

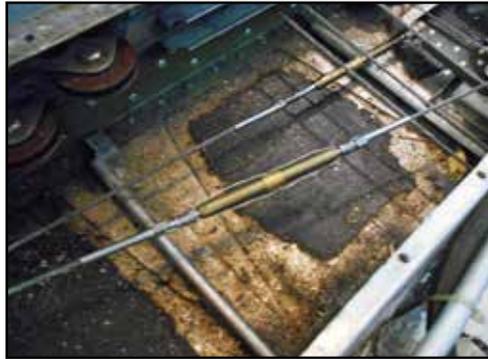
Typical oily mess found in the belly of a 40- to 50-year-old piston Twin Cessna.

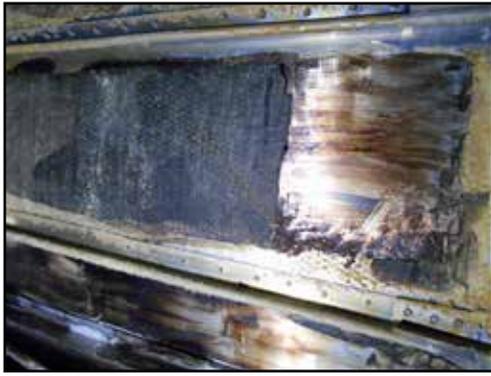
Skin damping tar partially removed by careful heating with a heat gun and scraping with a plastic scraper.

The process begins by removing all the old fiberglass residue with handheld wire brushes. Then we carefully use heat guns and plastic scrapers to remove the bulk of old skin damping tar. Next comes the tedious process of using a mix of lacquer thinner and mineral spirits to remove all the remnants of tar residue. Now it's time to use Roloc rotary abrasive wheels and Scotch Brite to remove any corrosion from the bulkheads, stringers, and cabin

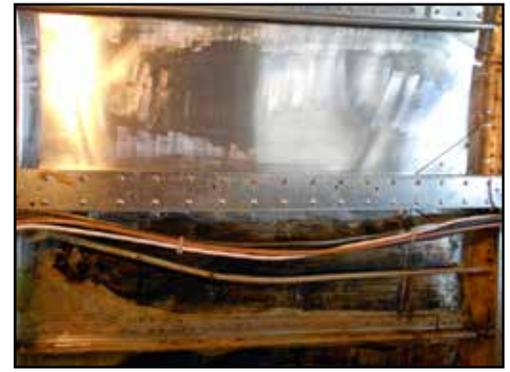
One section of a 310 cabin side skin, thoroughly cleaned with Scotch Brite and lacquer thinner.

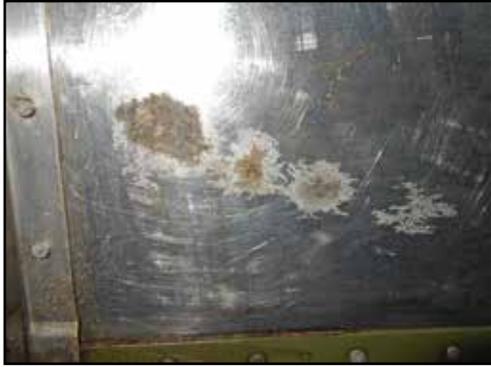
Corrosion often seen on a cabin side skin once the tar is removed.

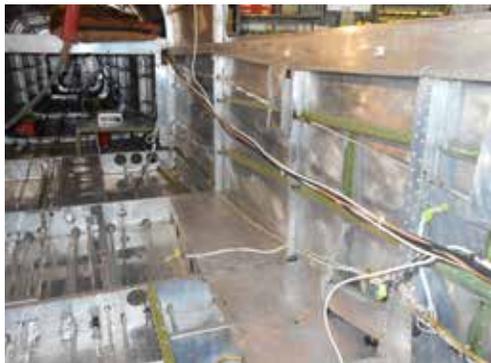
A 310 cabin, antiseptically cleaned showing partially masked wiring, cables and servos, almost ready for the application of zinc chromate.

With the inner cabin shining like a new airplane, we use aluminum foil to mask all the stuff that shouldn't be sprayed with zinc chromate. Aluminum foil is great for this, easy to apply, conforms to any shape, stays in place, and is easy to remove. This protection means we won't have issues with wires being pulled out of plugs.

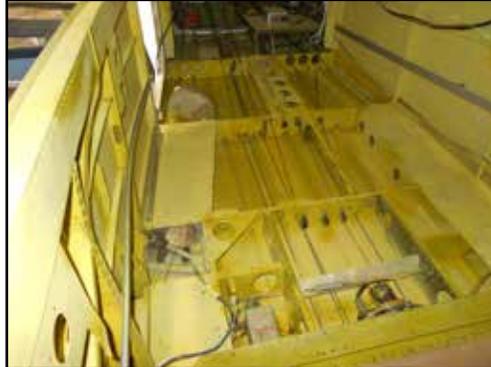
All chromated and finally ready to proceed with the interior renovation.

After everything is sprayed with zinc chromate, we will carefully apply Corrosion X or ACF50 to hard-to-reach places in both the main and aft spar areas as an extra precaution in our fight against corrosion. These airplanes are not replaceable, and it's rewarding to see the passion that folks put into their ownership.
