A Timeless 182

By Dennis Wolter

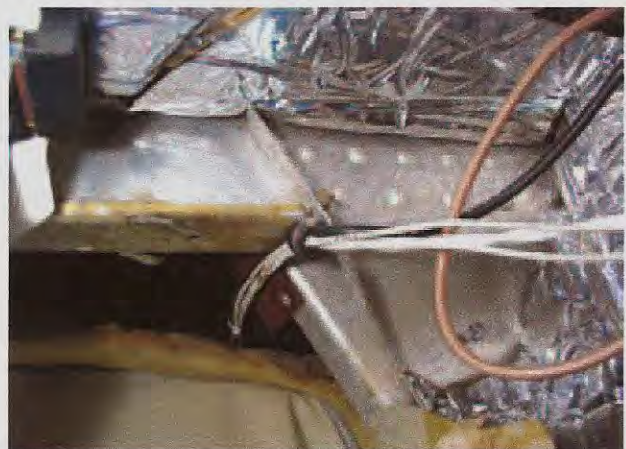
Super-clean forward spar attach fitting – typical of this entire airframe

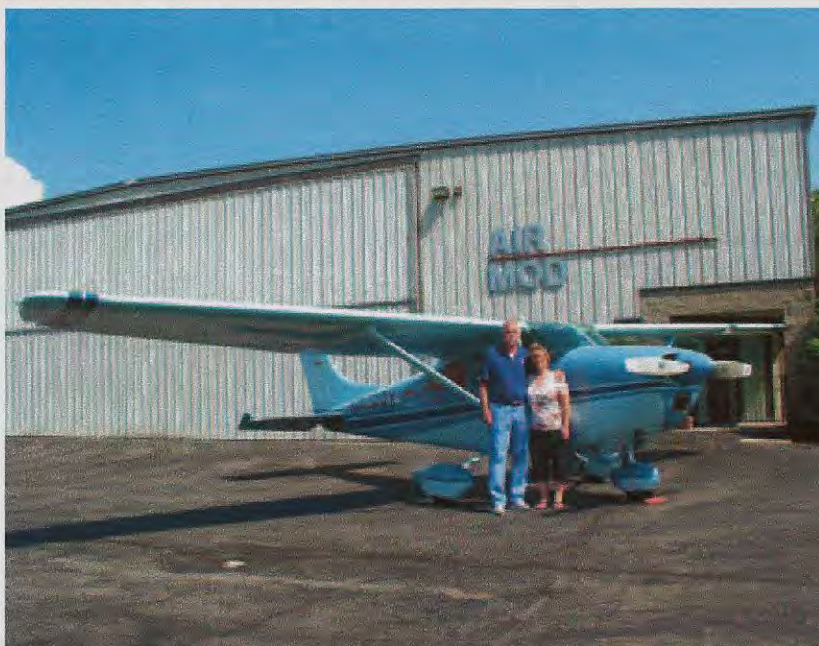
Newly painted, original color and design

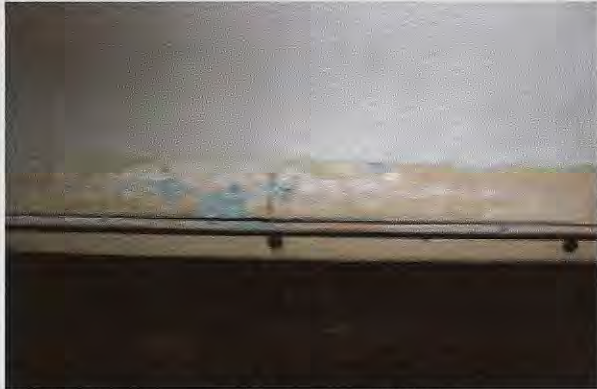
As we were in the process of removing some interior trim components, our lead tear-down technician Jeremy noticed some corrosion where the edge of that new headliner was tucked up

under the aluminum retainers along the edge of the cabin windows. Having seen this situation before, I asked Jeremy to pull the headliner loose above the pilot's door jamb. As he pulled the headliner material out of the retainer strip, copious amounts of aluminum oxide dust came with it. After getting approval from Dan, we removed the entire headliner. We found fast-growing corrosion anywhere the headliner vinyl backing touched the shiny, bright aluminum. Unfortunately, I have seen this situation many times in the past. The culprit here is a strong corrosive bromide flameproofing solution that was sprayed on the cloth backing of the vinyl in order to get it to pass the FAA's flame proofing specification, FAR 25.853. All too often, unknowing material suppliers or interior technicians will spray un-flameproofed vinyl, leather or carpet with this after market chemistry – a very bad idea. The level of corrosion shown in the photographs took about 18 months to develop; luckily we caught it in time. With the replacement of retainer rails, a thorough cleaning and chromating, and a new headliner, the situation has been completely corrected.

Severely corroded headliner retainer strip

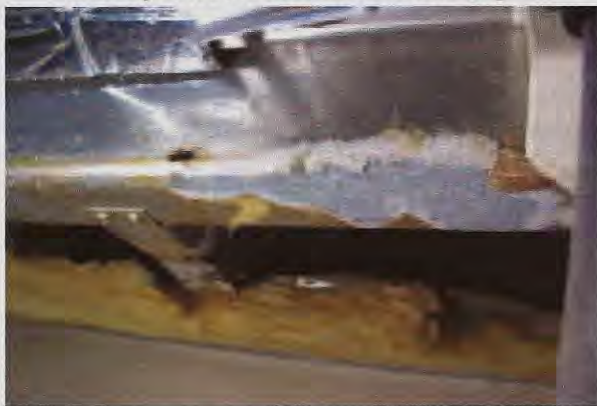
Corrosion on the surface of the aft spar carry-thru where the contaminated headliner touched it

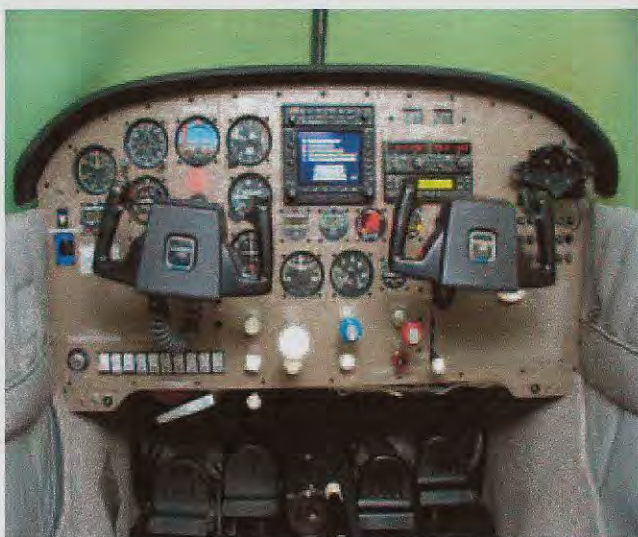
A great avionics package and well built all-metal instrument panel with new switches and circuit breakers

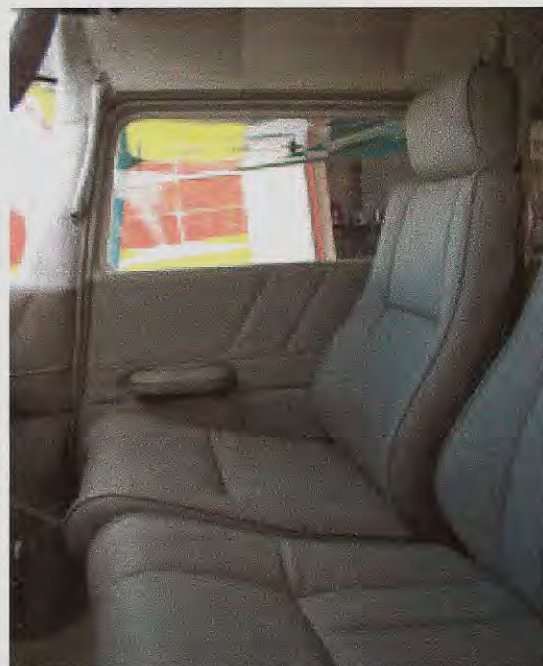
Very functional, maintainable ergonomic interior with newer-style articulating seats
